# STRAUB HALL INTERIORS PRELIMINARY HISTORIC ASSESSMENT

CAMPUS PLANNING AND REAL ESTATE - JANUARY 2011

This assessment identifies Straub Hall's historically significant interior finishes, features, and spaces.

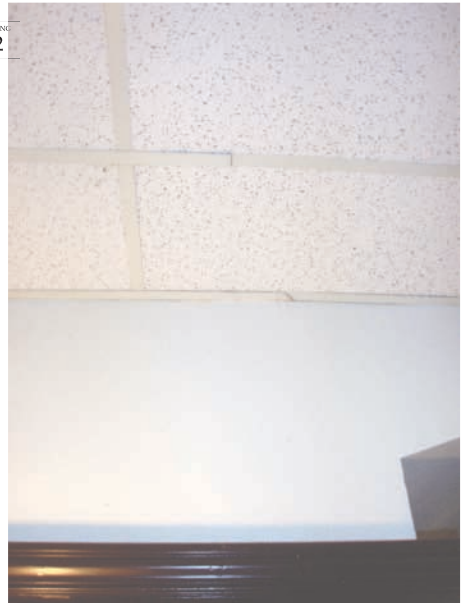
At one point the room was split into two offices, which is still evident in the remaining scars in the ceiling panels and on the walls. The room was returned to its original configuration some time ago.

^ SCARS FROM PREVIOUS DIVISION.

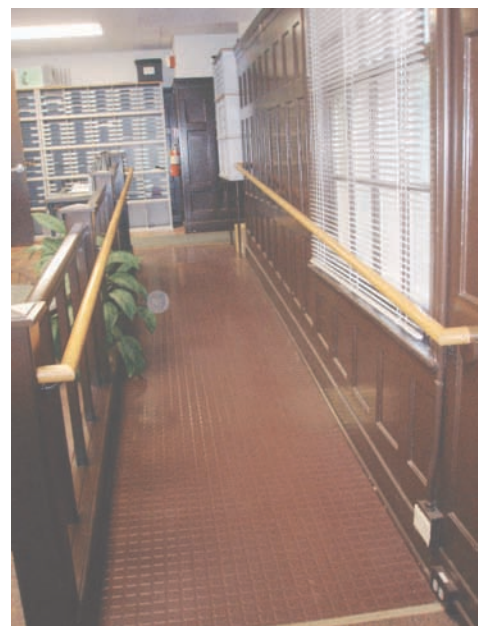
**Alterations:** The ramp along the west wall, as well as the paneling along the same wall, were 1974 ADA additions. The archway was effectively widened 3' when the closet and adjacent wall were removed to allow for the ramp. The mirror above the mantle was removed and the carpeting was installed. It is unclear if the original taupe linoleum flooring remains underneath the carpet.

^ NEW RAMP AND WALL PANELS.

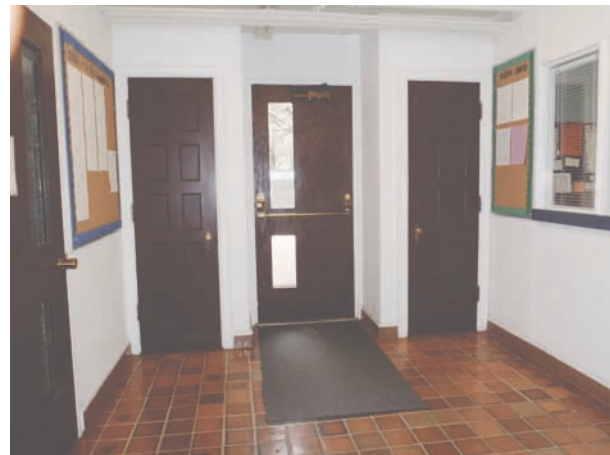
^ ENTRY PASSAGE.

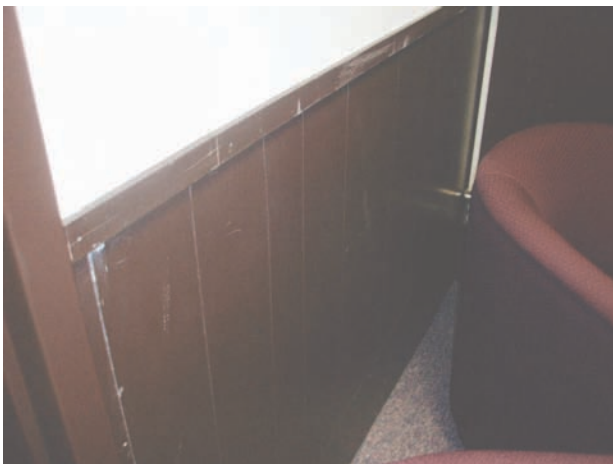
All of the wainscoting, doors, and hardware have been replaced. Also, the bricks surrounding the fireplace and the terra-cotta tiles are thought to be of a different era.

^ WAINSCOTING DETAIL.

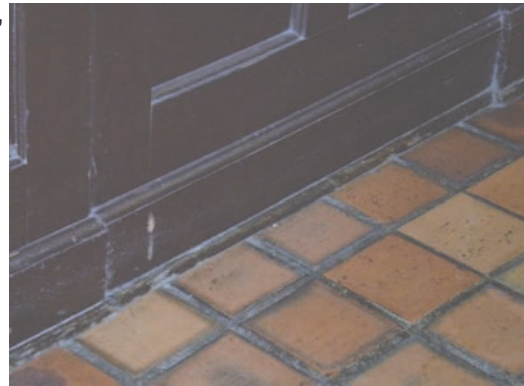
^ FLOOR TO BASE DETAIL.

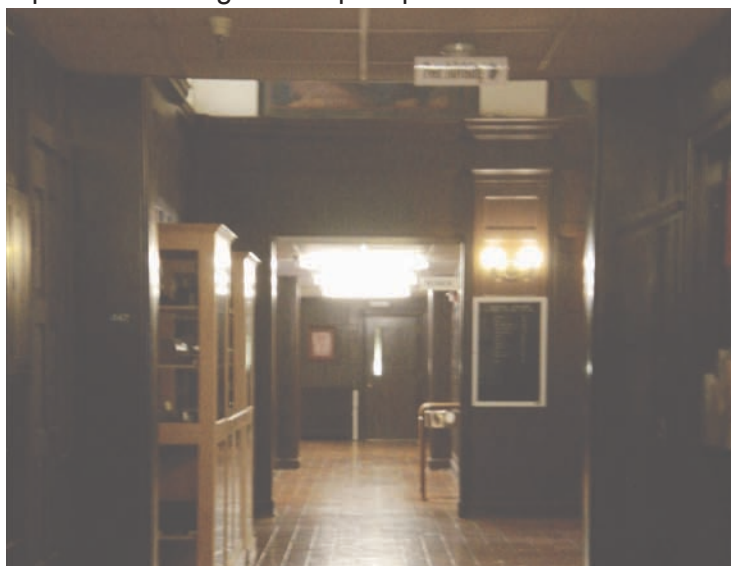
Significant portions of the wood paneling have been replaced due to general upkeep.

^ NORTH HALLWAY LOOKING SOUTH.

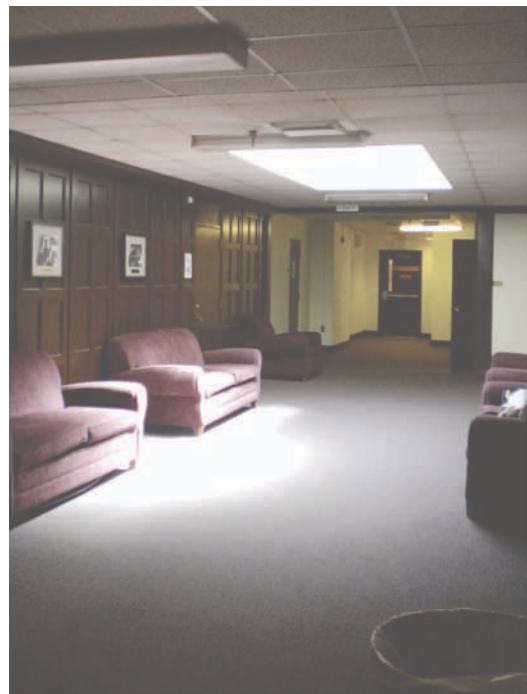
The original ceiling has been covered by a suspended acoustical tile system.

The paneled walls of this space are the original accordion walls. They have been fixed into place and the joints have been covered with battens. The original scars from the bumpers and the walls scraping against the moldings are still visible on the accordion panels.

^ NORTH SKYLIGHT HALLWAY.

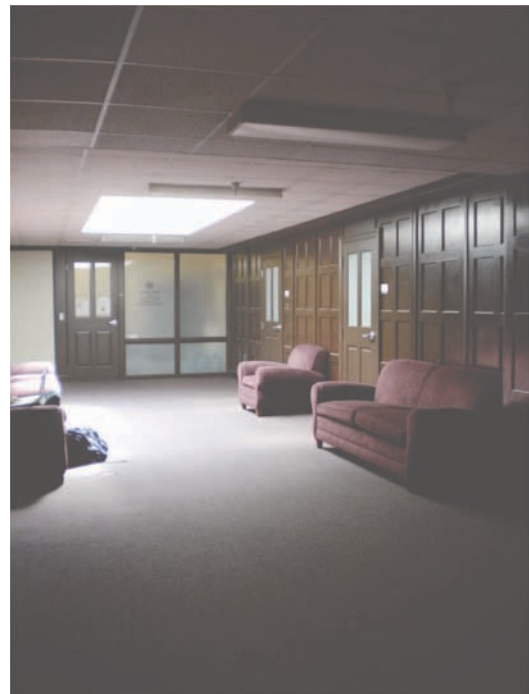
The original ceiling has been covered by a suspended acoustical tile system.

Again, the panelling that you see is the original folding wall. When the battens are removed, the sections (complete with hardware scars) are visible.

^ SOUTH SKYLIGHT HALLWAY.

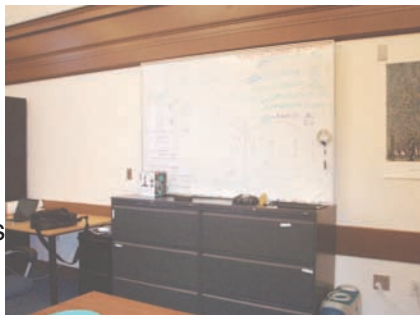
New doors leading to the hallway at the west end of the room replaced a portion of the original accordion wall, now fixed in place. They are covered by a whiteboard and storage cabinet. The doors were kept to allow large equipment to be moved in and out, though these doors are never used.

^ FURNITURE BLOCKED WEST DOORWAY.

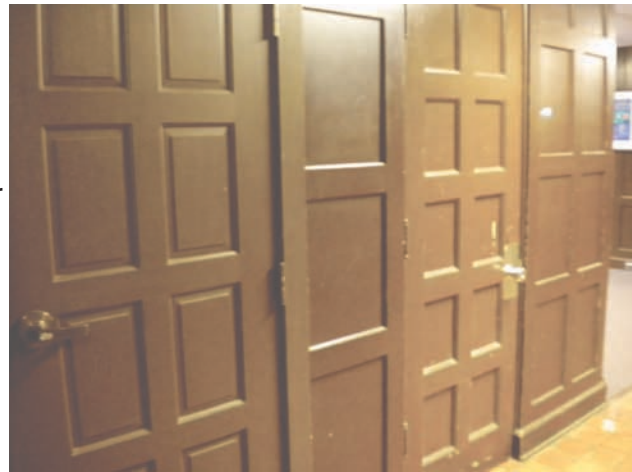
^ HALLWAY DOOR STYLES.

The east wall’s material and double doors are not original but were added in the 1974 remodel and have been preserved since then. A door to what was a trunk room (now a collection of small offices and subject run rooms) has been sealed, but the molding remains. The doors throughout the space are all different, only one being the original style (north of the skylight, first door to the east).

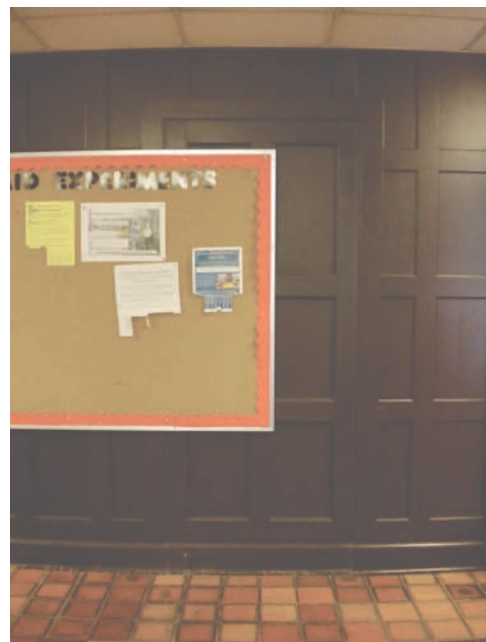
^ SEALED DOORWAY.

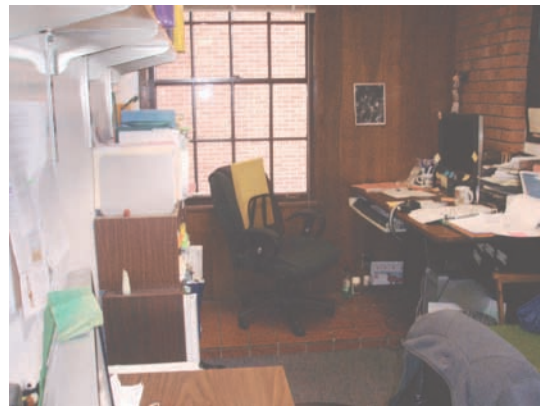
**Historic Materials:** The firebox. The tiles at the fireplace's base extend to the south wall, even though a partition has been added over them. The ceramic floor tile entrance is intact - identical to 137/139.

^ FIREPLACE TILING EXTENDING.

**Alterations:** This room has been divided into two rooms, bisecting the fireplace's tiles. The bricks surrounding the fireplace and the wainscoting have been replaced, along with the addition of the office door. The ceiling tiles have been glued onto the original ceiling; no moulding remains.

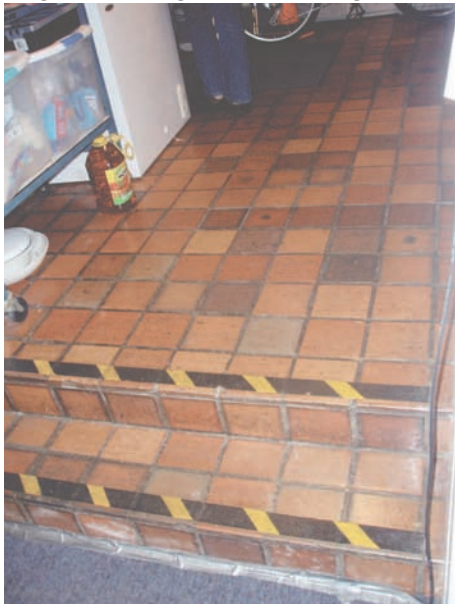
^ ENTRY CERAMIC TILES.

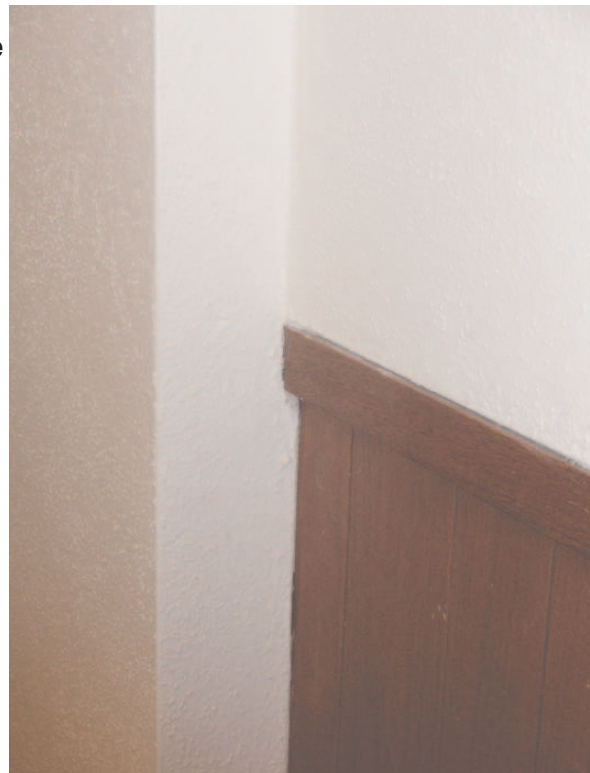
^ WAINSCOTING DETAIL.

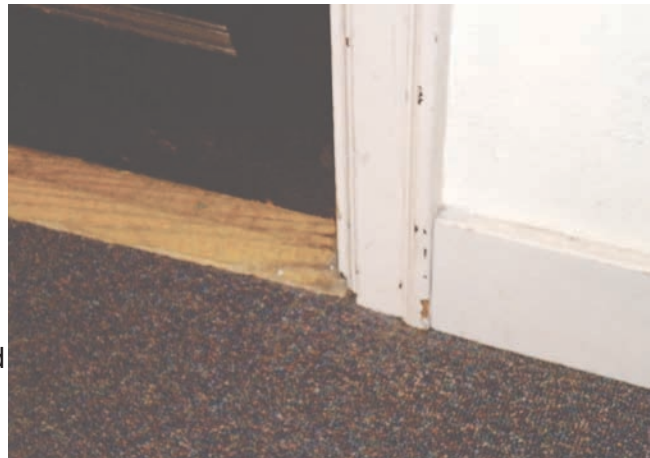
^ SECOND FLOOR BASEBOARD DETAIL.

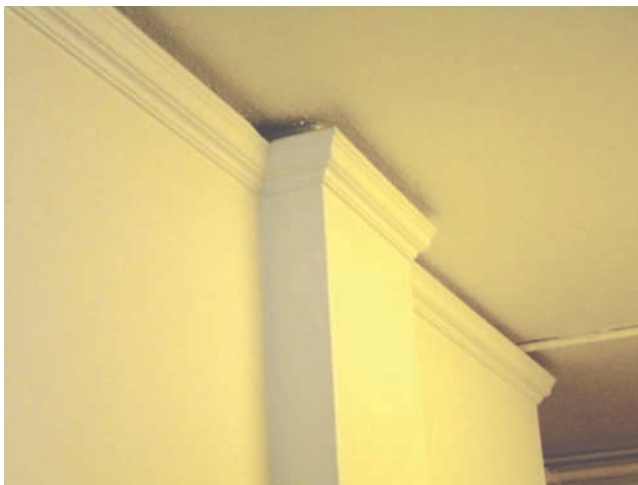
^ MOULDING DROP DETAIL.

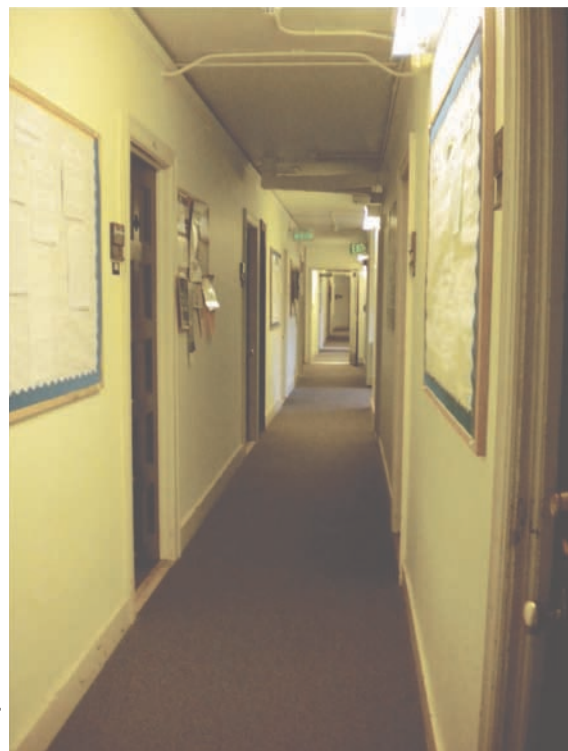
**Alterations:** In 1974 surface-mounted piping and electrical conduits were added. An elevator shaft and fire doors were also added. In 1984 new carpeting was installed. It is unclear if the original taupe linoleum remains under the carpet.

SECOND FLOOR HALLWAY. >

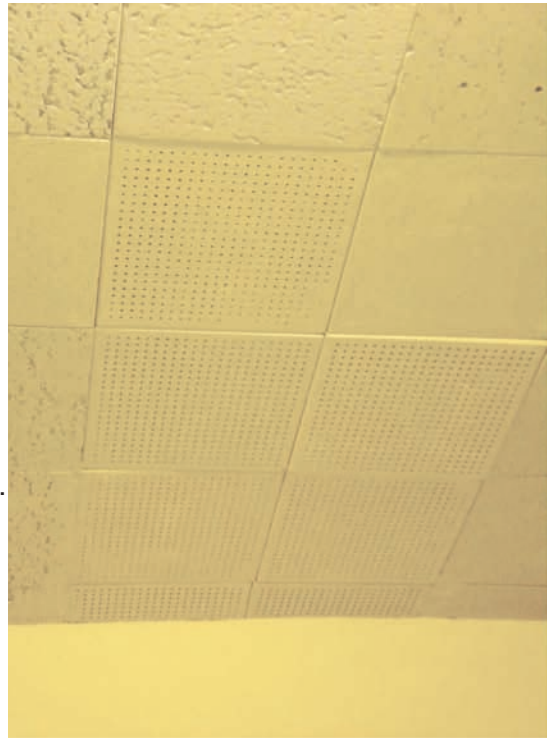
^ SOUTH HALLWAY CEILING DETAIL.

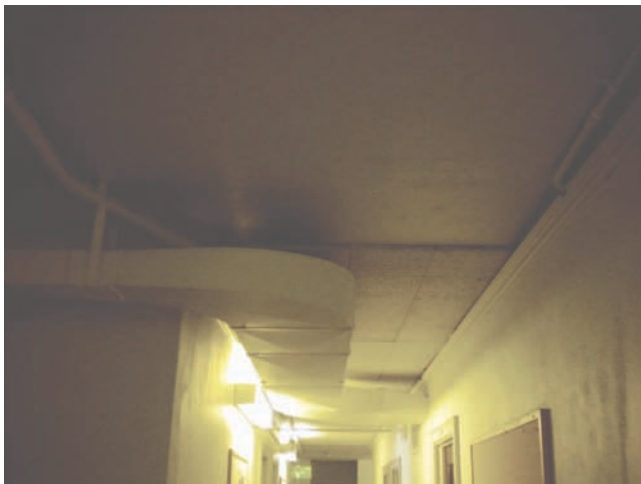
^ END OF ACOUSTIC PANELS DETAIL.

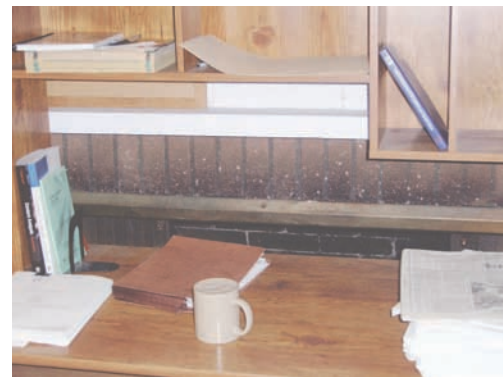
**Alterations:** The space was divided into three offices. All wall, floor, and ceiling finishes were altered. The fireplace's brick and tile work may have been removed and replaced.

^ FIREPLACE.

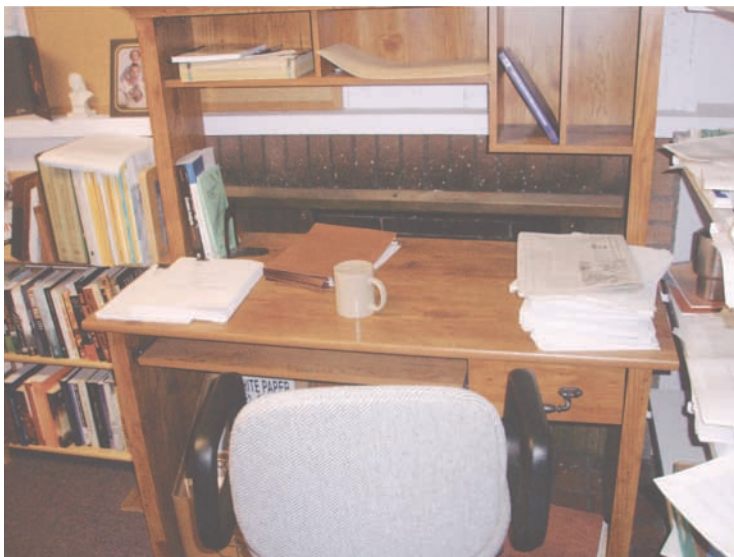
^ FIREPLACE CONTEXT.

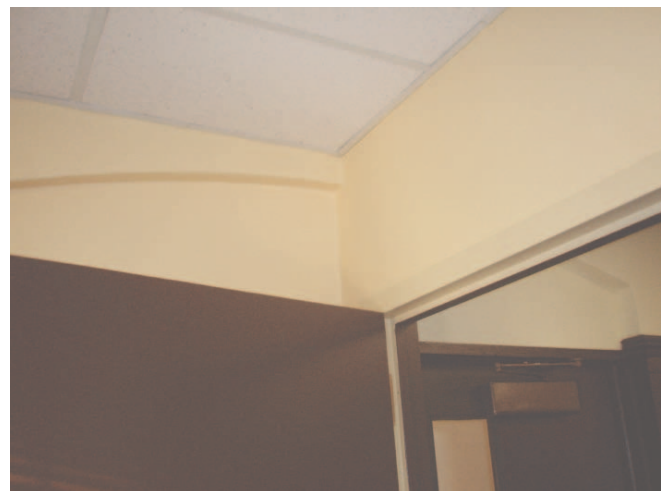
^ ENTRY ARCHWAY DETAIL.

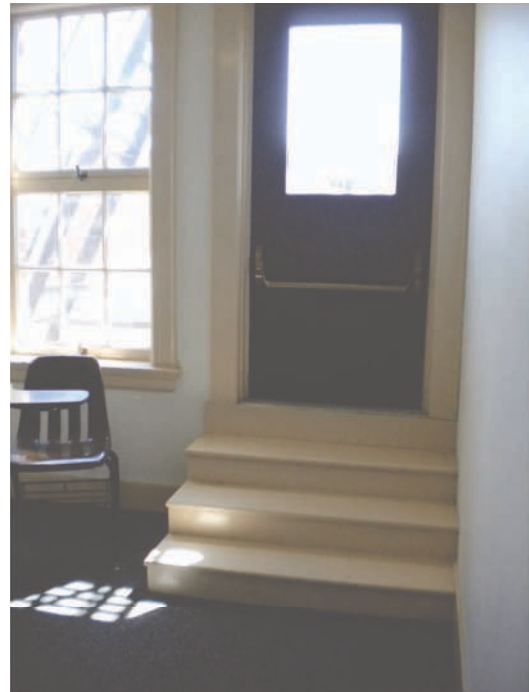
^ NORTH HALLWAY 3RD FLOOR FIRE ESCAPE.

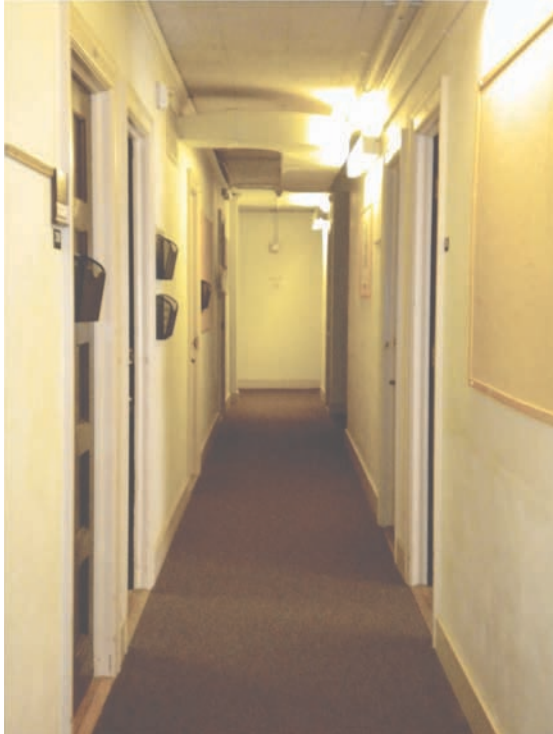
**Alterations:** New doors; all exposed piping, fire doors, electrical, and mechanical units were added. In 1984 new carpeting was installed. It is unclear if the original taupe linoleum remains under the carpet.

^ NORTH HALLWAY 3RD FLOOR.

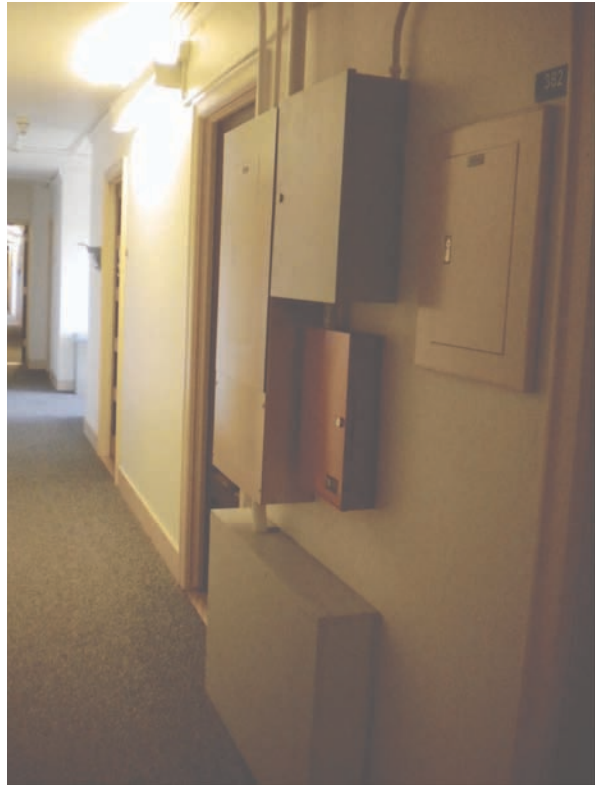
^ SOUTH HALLWAY THIRD FLOOR.

**Alterations:** New doors; all exposed piping, fire doors, electrical, and mechanical units were added. In 1984 new carpeting was installed. It is unclear if the original taupe linoleum remains under the carpet.

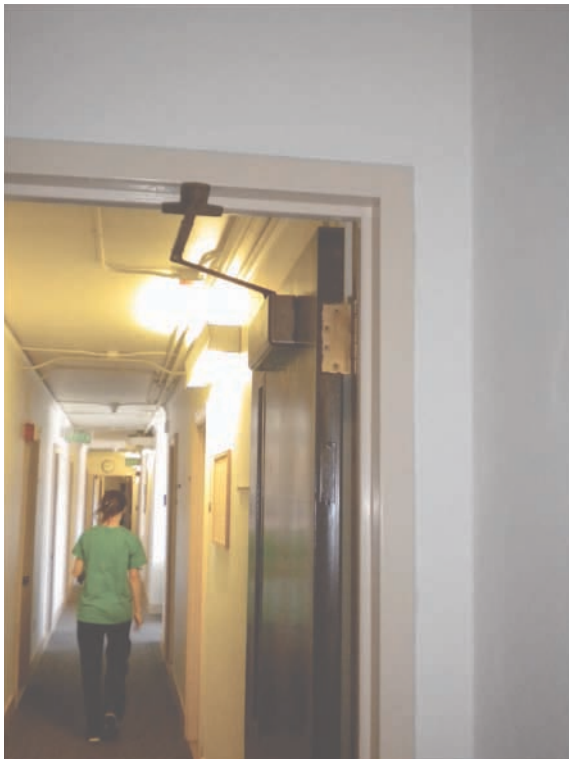
^NEW FIRE DOOR DETAIL.

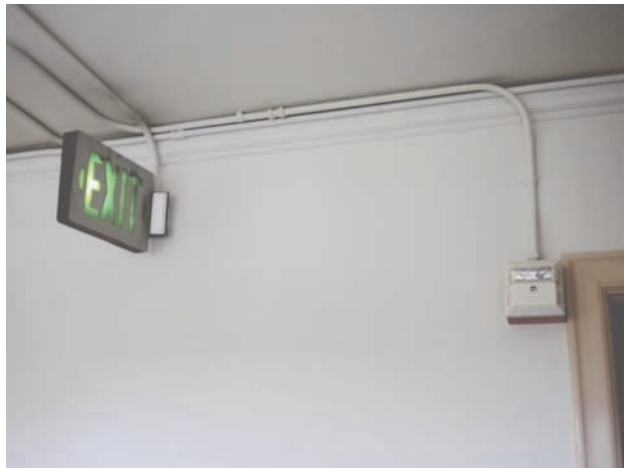
^ELECTRICAL DETAIL.

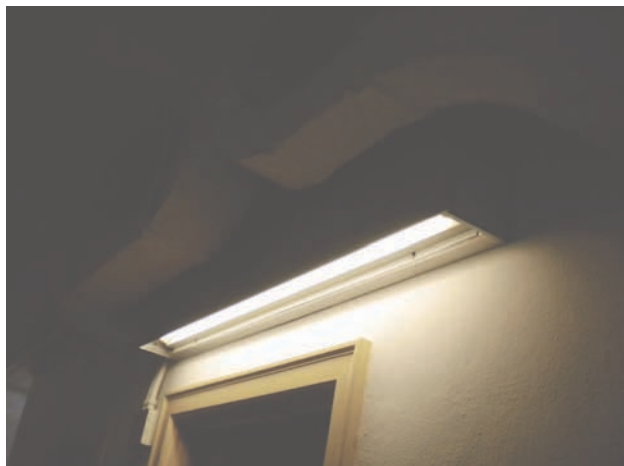
^MECHANICAL DETAIL.

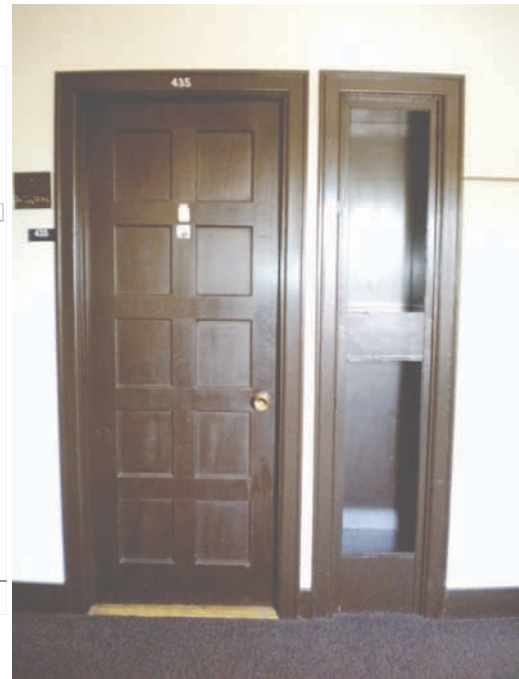
^ NORTH HALLWAY 4TH FLOOR ORIGINAL DOOR AND TELEPHONE CASE.

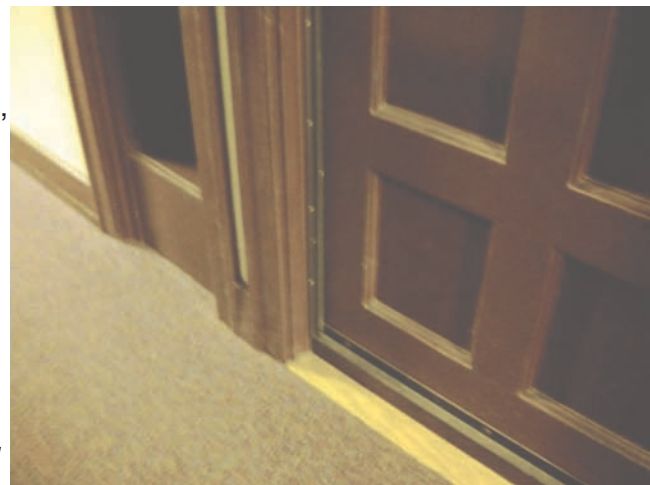
^ NORTH HALLWAY 4TH FLOOR BASE DETAIL.

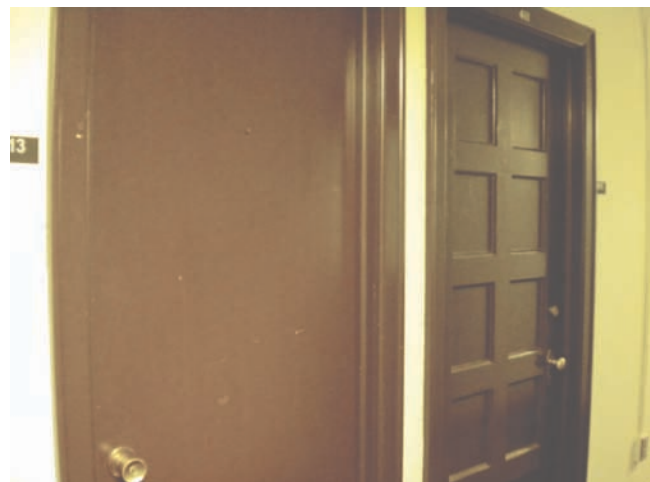
**Alterations:** All exposed piping, electrical, and mechanical units were added, as were fire doors and a fire escape door. In 1984 new carpeting was installed. It is unclear if the original taupe linoleum remains under the carpet. A few doors have been replaced as well (see *North Hallway 4th Floor New vs. Old Door*).

^ NORTH HALLWAY 4TH FLOOR NEW VS. OLD DOOR.

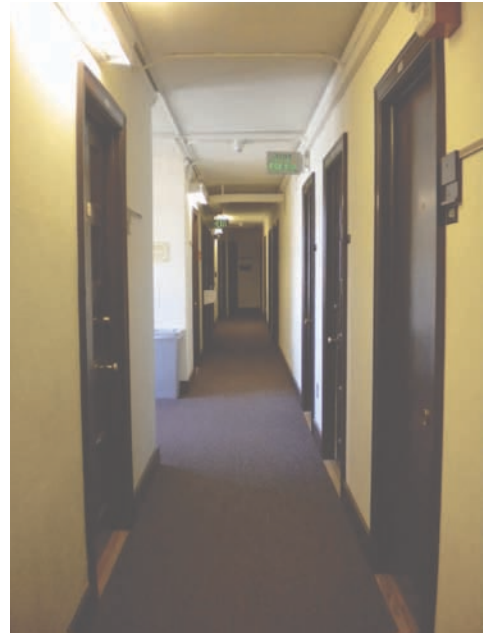
^ SOUTH HALLWAY 4TH FLOOR.

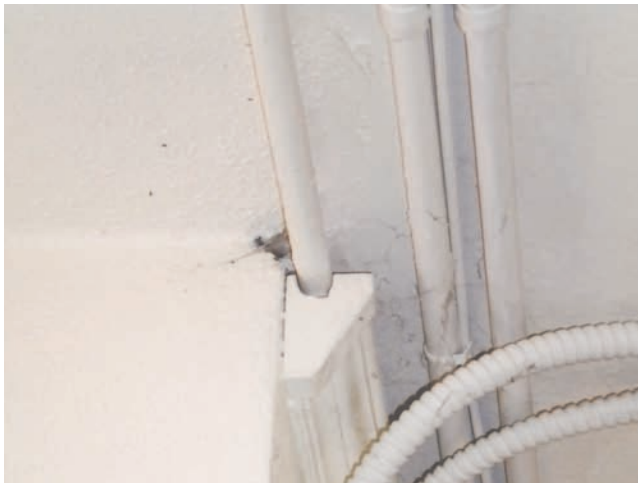
^MOLDING AND PIPING DETAIL.
