EXPERIENCE IN OPERATING THE STRUCTURES OF THE MANSOUR EDDAHBI HYDROPOWER DEVELOPMENT

I. F. Blinov and O. V. Sitnin

Translated from *Gidrotekhnicheskoe Stroitel'stvo*, No. 10, pp. 25-30, October, 1983.

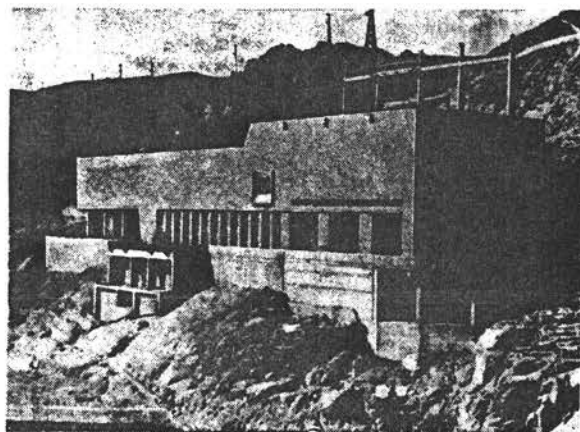
Fig. 2. General view of powerhouse.

The structures of the hydrostation are in good condition. During the time of operation not one structure has been repaired. All rooms of the shaft of the station are dry; no discharges of seepage water through the shaft walls have been observed.
