OREGON INVENTORY OF HISTORIC PROPERTY
ELLIS LAWRENCE BUILDING INVENTORY
COUNTY: Crook

HISTORIC NAME: ROBINSON & CLIFTON BUILDING

ELLIS LAWRENCE BUILDING SURVEY
 HISTORIC NAME: ROBINSON & CLIFTON BUILDING

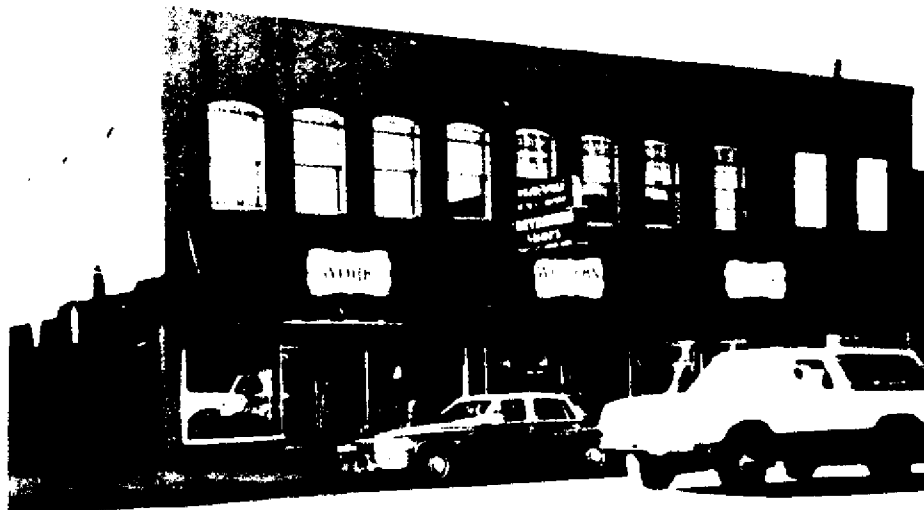
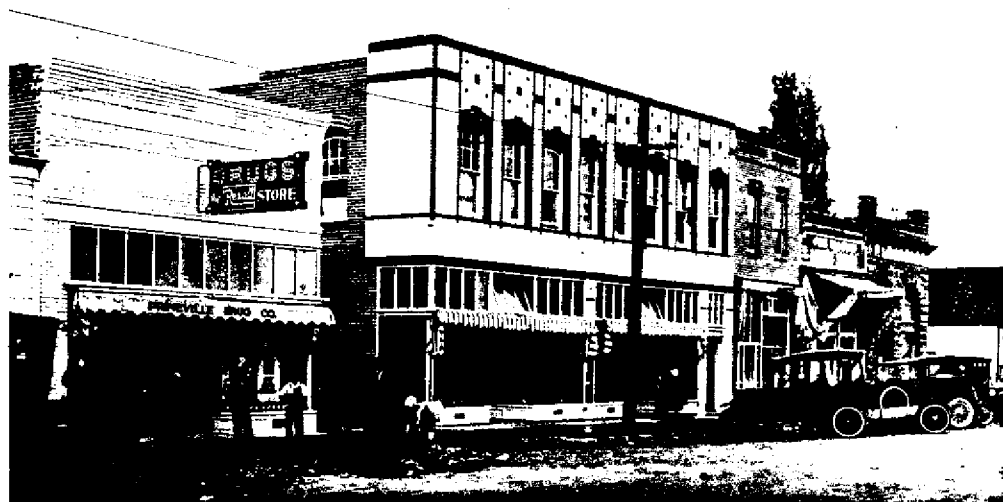
RECENT PHOTO
 NEGATIVE #s:
 MS5-35 (copy n)

First # above
 is upper-right
 photo; second #
 is just below.
 If no # above,
 see sources at
 bottom of page.

HISTORIC PHOTO/OTHER GRAPHIC SOURCE: Crook Co. Historical Society Bowman Museum
