National Register of Historic Places Registration Form

historic name Ladd Carriage House
other names/site number _____

street & number 1331 SW Broadway Street not for publication
city or town Portland vicinity
state Oregon code OR county Multnomah code 051 zip code 97201

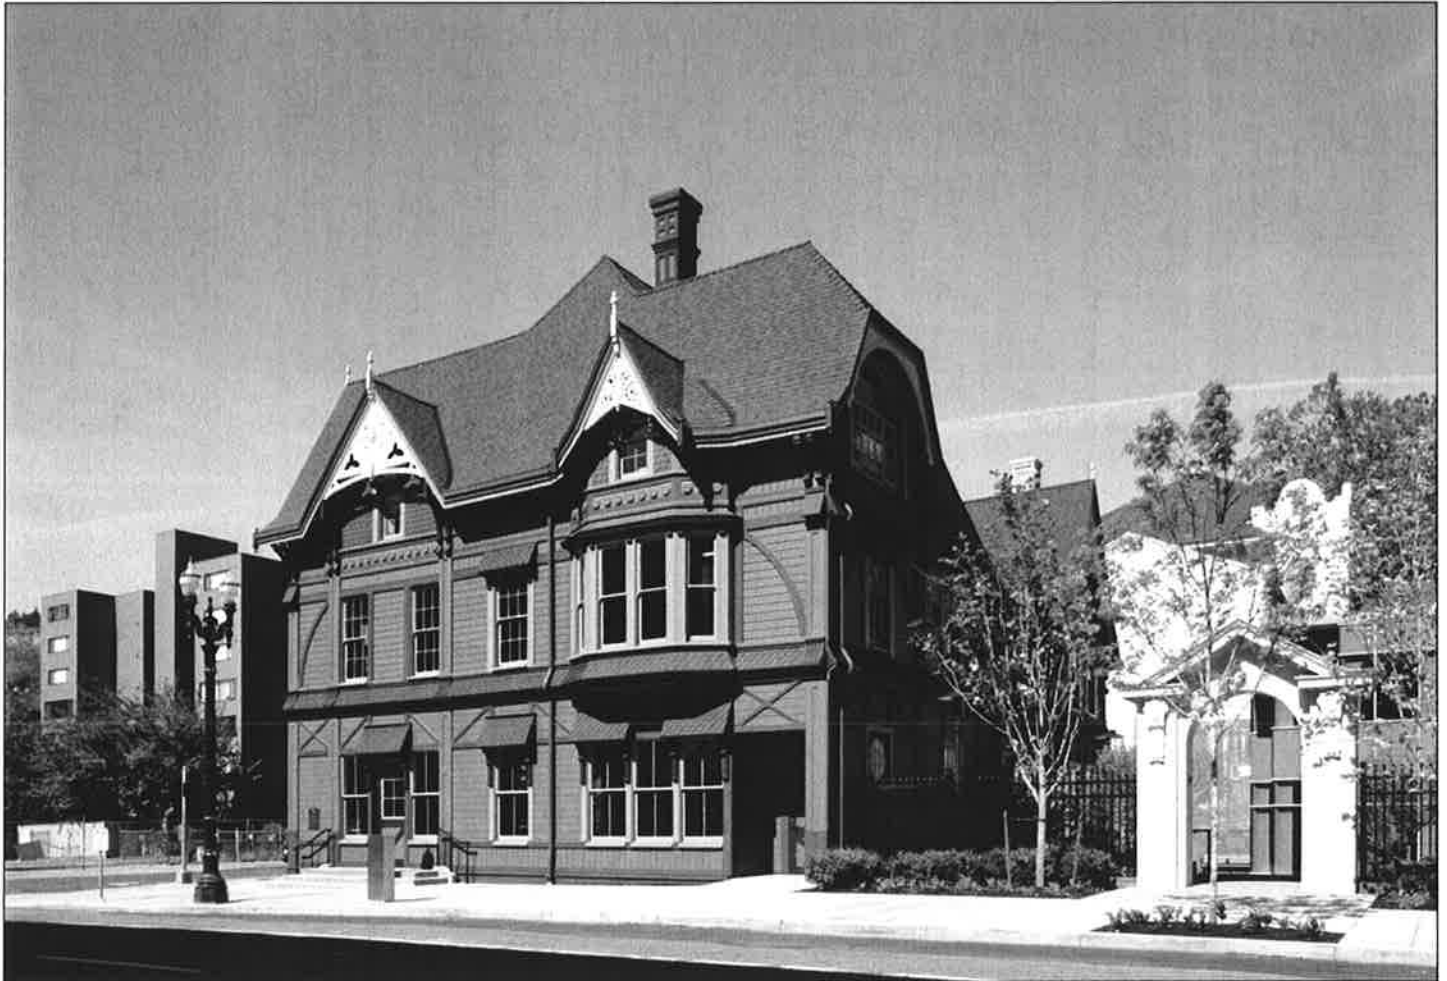
1 of 15: East facade. View to W.

The east elevation of the Ladd Carriage House, one of the two primary facades, is three stories in height with two prominent gable ends framing the roof line. The asymmetrical façade is broken into three well-defined bays. The bays themselves feature a relatively high degree of symmetry, but are broken by a horizontal belt cornice running at the base of the second floor. The 48-foot, nine-inch wide elevation features two doors, 15 windows, four prominent vertical pilasters that rise from the ground to the eaves, and an oriel window bay that extends a portion of the second and third floors beyond the first-floor footprint.

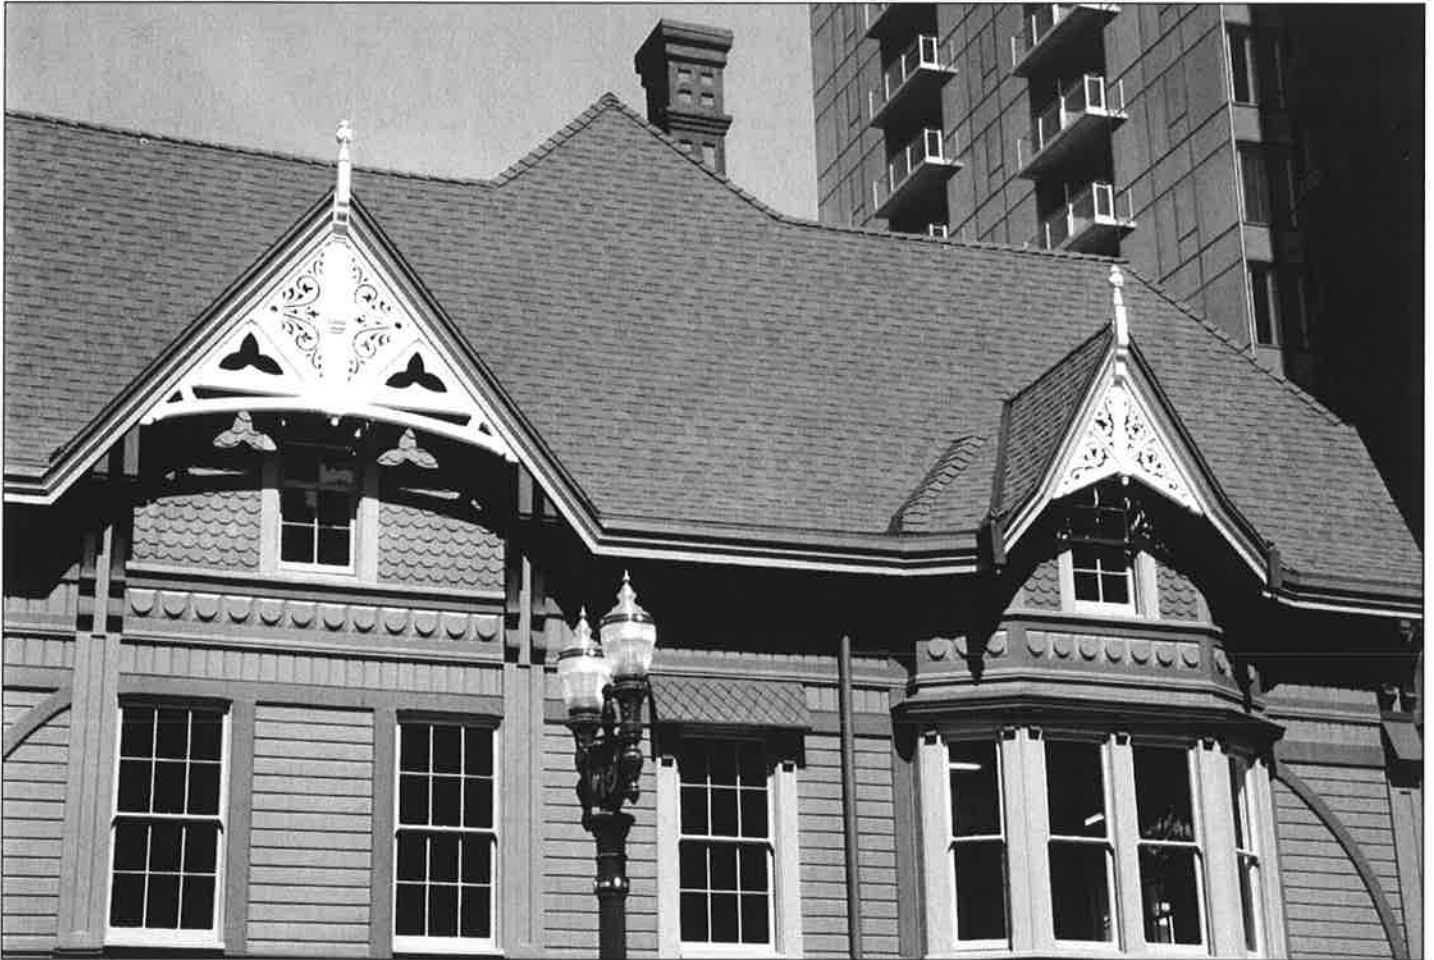
2 of 15: East façade: detail of gable trceries. View to W.

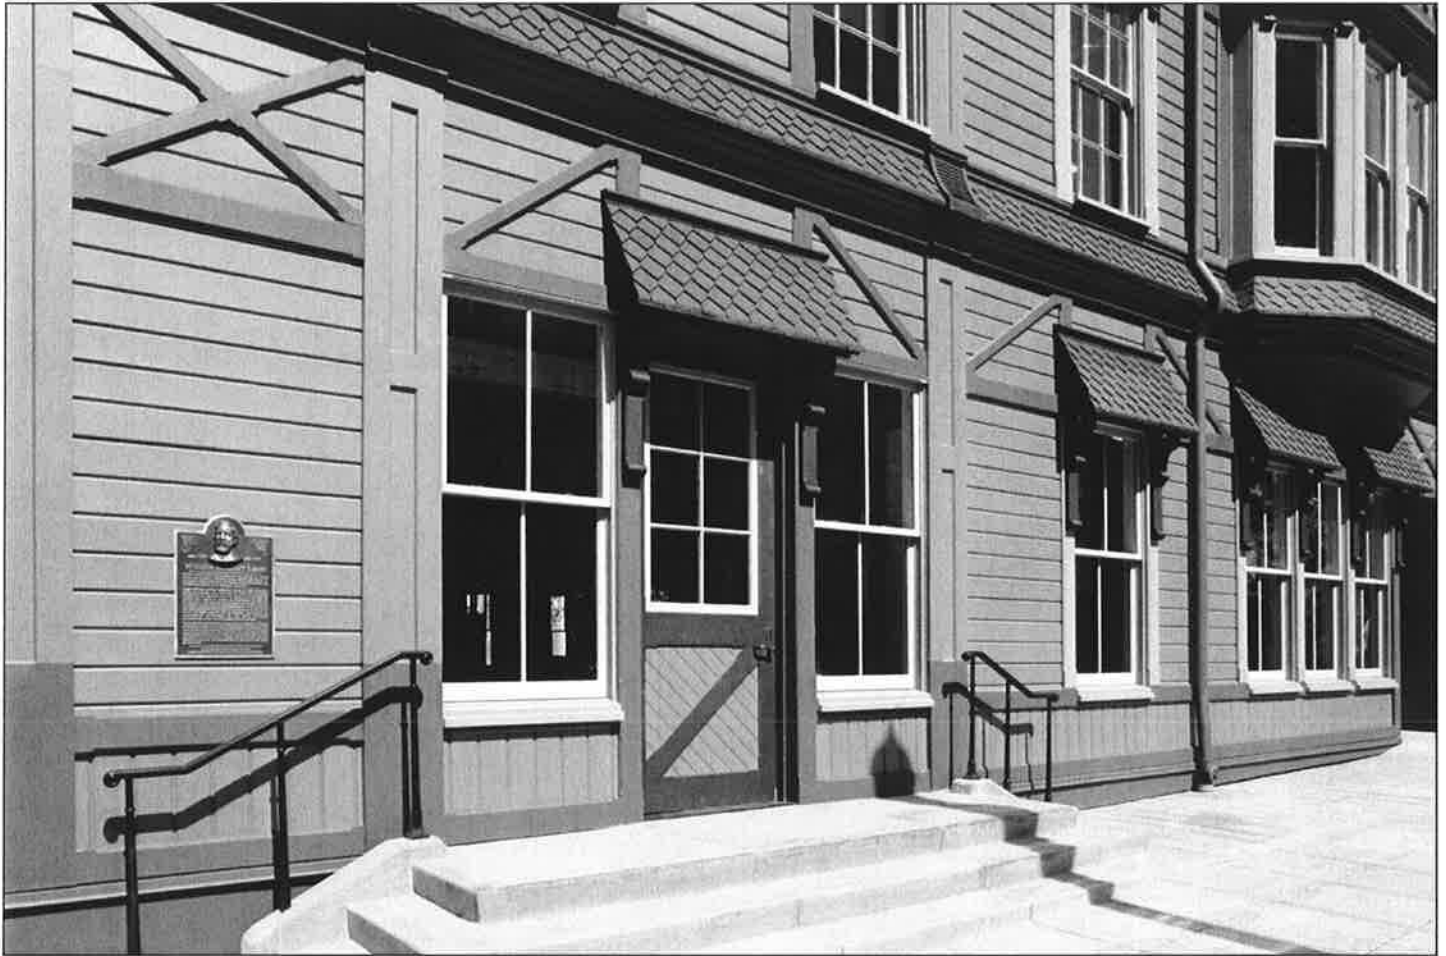
3 of 15: East façade: detail of ground floor. View to NW.

A flush waterboard and drip cap conceal the new concrete foundation (which was originally of masonry construction). Above the drip cap, a low section of vertical V-notch siding further defines the base of building. The building is supported by an underground parking garage, which is not discernable from the exterior.

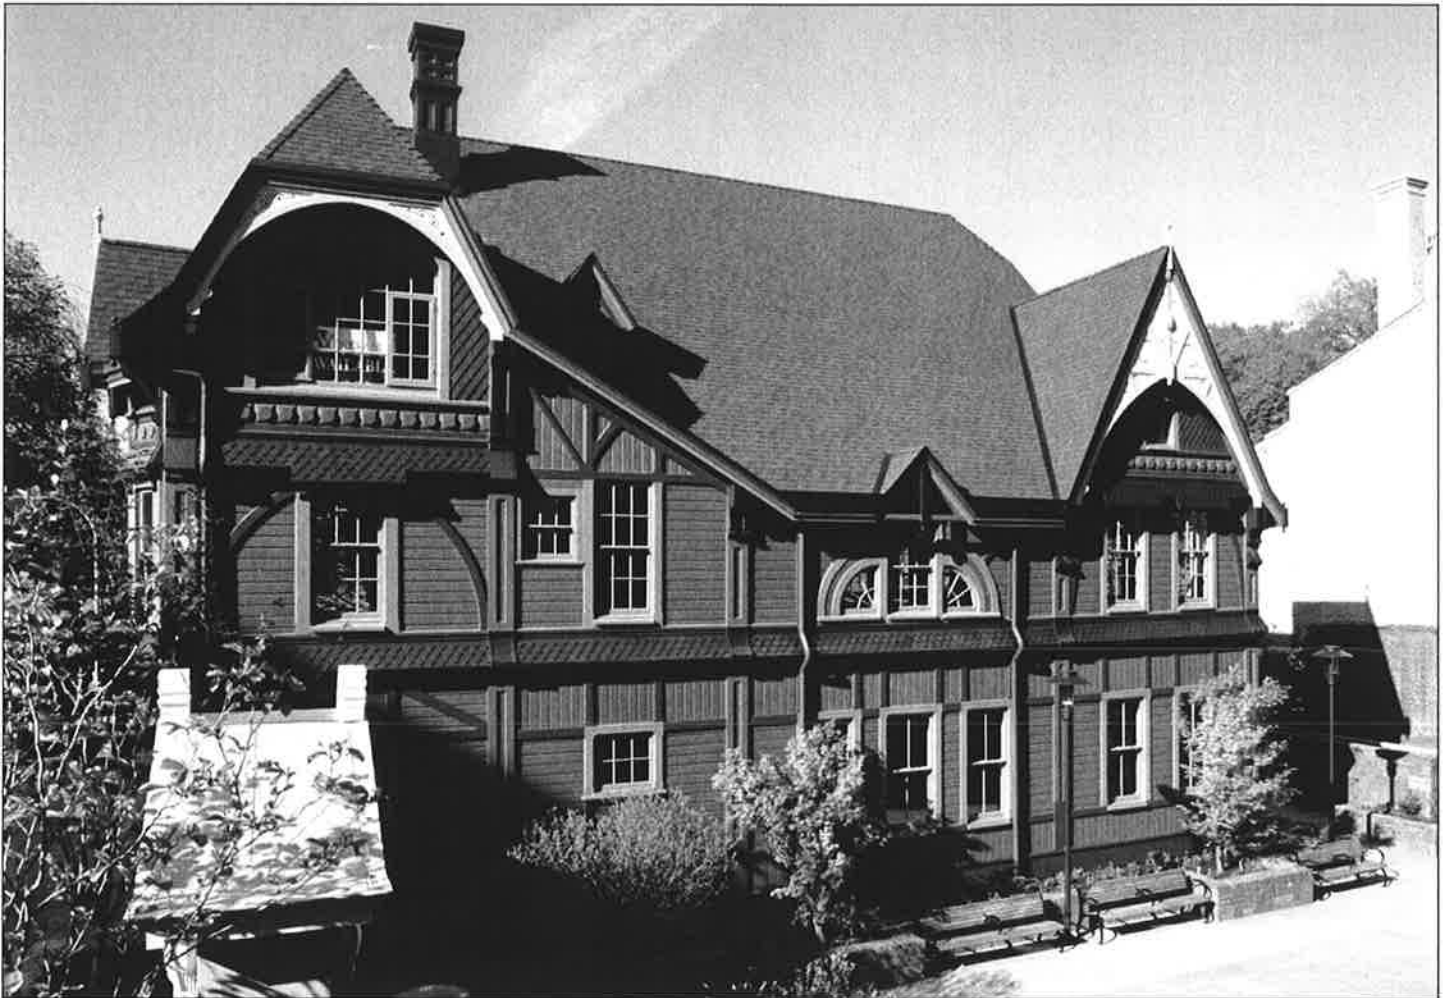
7 of 15: North façade. View to SW.

Originally the Ladd Carriage House's least visible elevation—the north elevation features four bays, a regular gable, and a jerkinhead gable. The location of a residence four feet away (building-face to building-face) from the north elevation obscured the façade from most early photographic records. Furthermore, a 1968 fire that destroyed this residence caused severe damage to the exterior of the Carriage House, resulting in the loss of much of the original siding and many of the windows on the elevation. Like the other elevations, the north façade features pilasters that divide the bays, and general symmetry within the bays; however, the north elevation's second easternmost bay is irregular because it is asymmetrical.

Because of the lack of historical documentation and the damage caused by the 1968 fire, the north elevation's integrity is difficult to assess. Because many of the elements of this secondary façade correspond to documented elements on the south façade, the north elevation maintains the feel and configuration that likely existed at the time of construction. Because the arched multi-light window on the third floor is obviously out of scale to the building, it is likely a product of the repairs following the 1968 fire. Of the 18 windows on the north elevation, only three date to 1883.

In 1968, a fire in the house to the north caused surface damage to the north façade of the Carriage House. Hoffman Construction replaced the ornamentation on the exterior wall surfaces and closed up original sash openings with gyp board and V-notch drop siding.

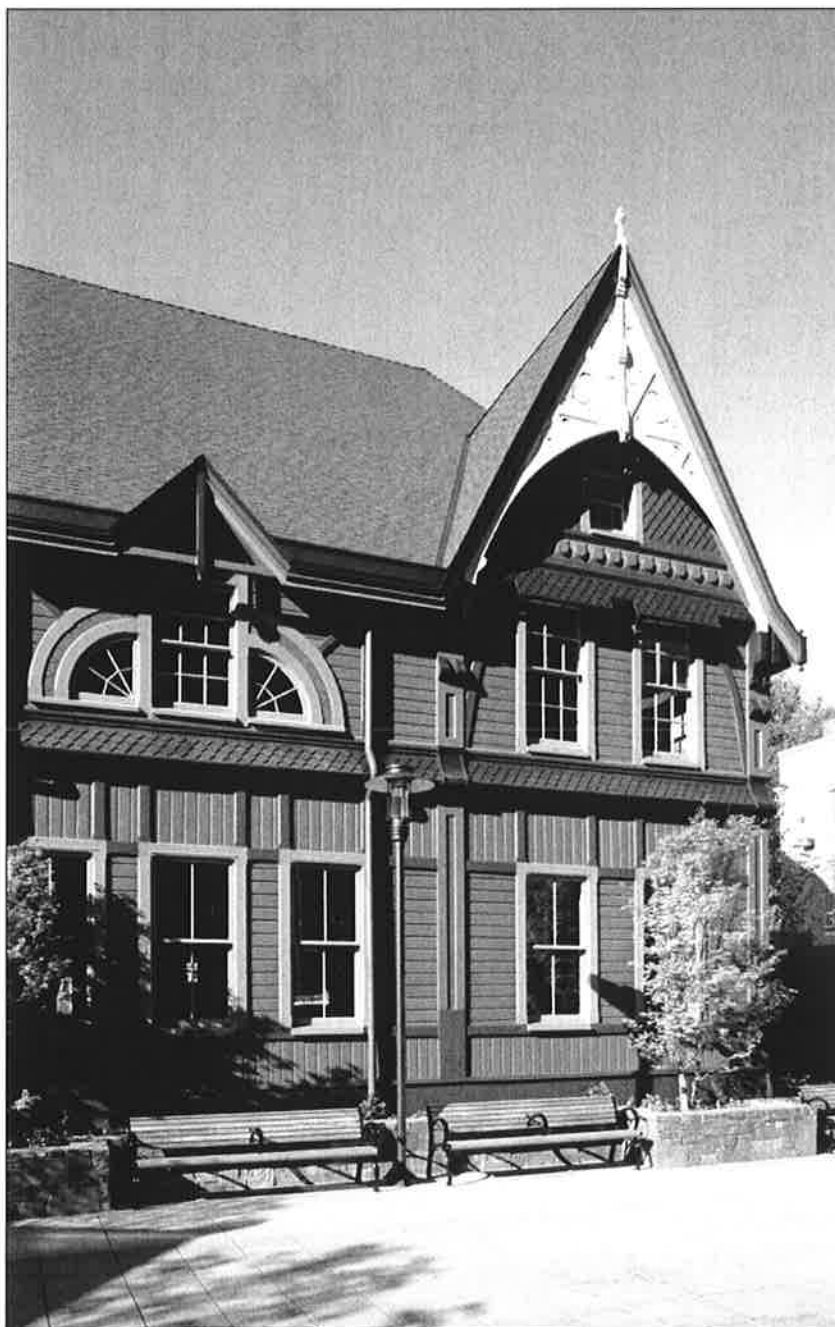
8 of 15: North façade: details of easternmost bays. View to SW.

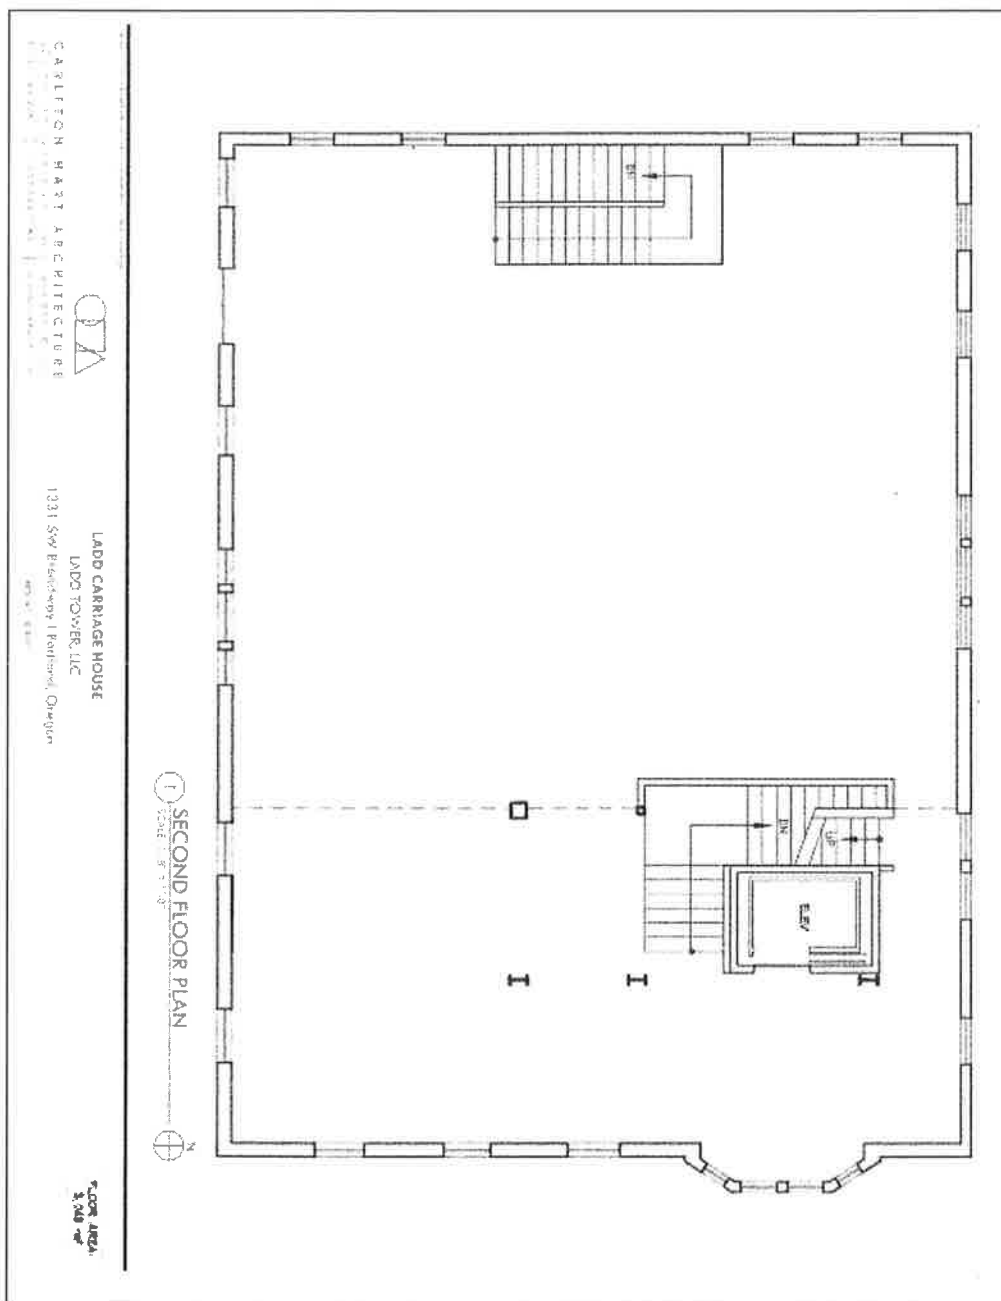
3. Ladd Carriage House Floor Plans – 3 Sheets. Floor 2.

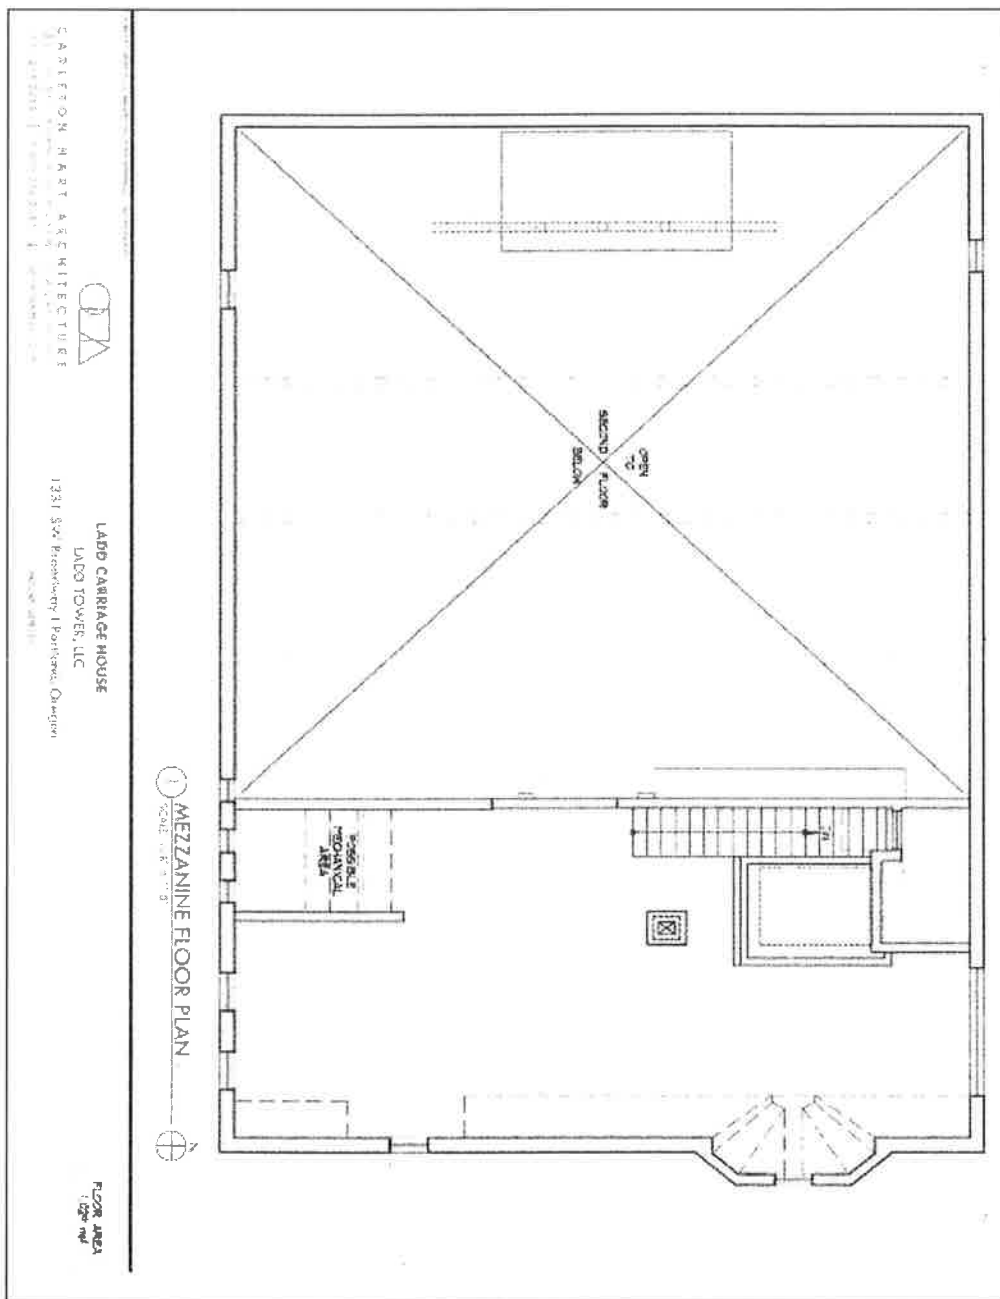
3. Ladd Carriage House Floor Plans – 3 Sheets. Mezzanine.

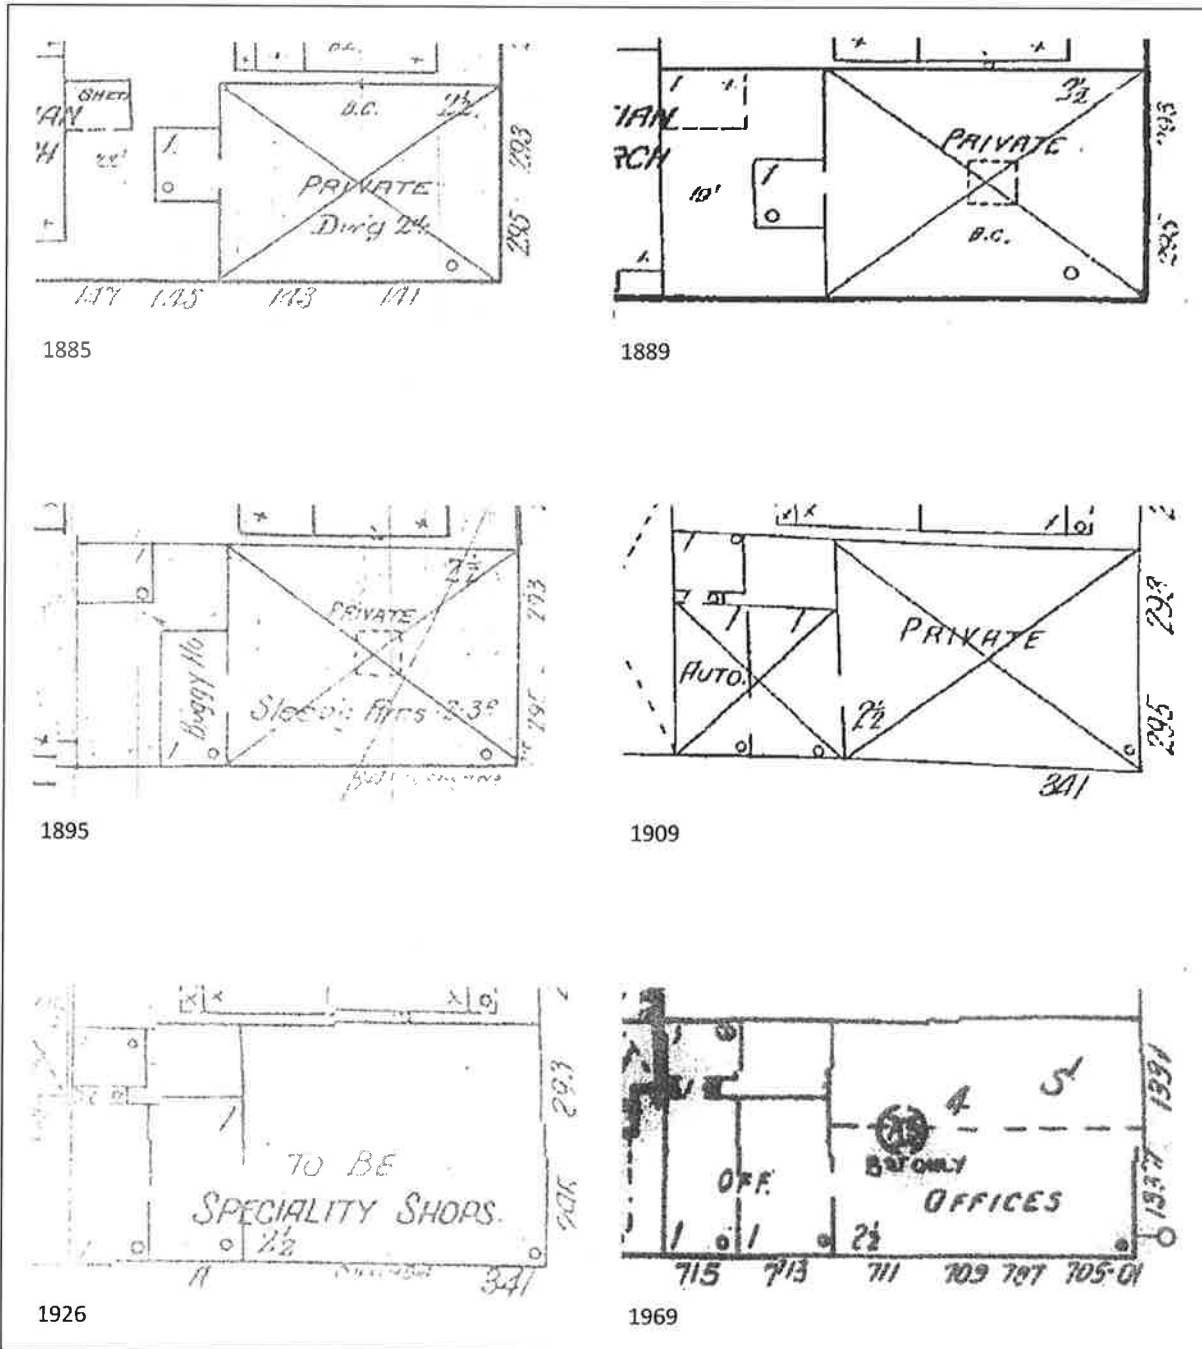
4. Exhibit A: Sanborn Fire Insurance Maps.

Sometime between 1889 and 1895, the projecting western wing was replaced and a new structure built for use as a buggy house. Photographs in the First Christian Church archives show the utilitarian buggy house with a large opening and ramp to Columbia Street. The buggy house adjoined the main structure and abutted the Columbia Street sidewalk, removing the two-ground floor windows originally located on the east end of the main structure's west elevation. Approximately twenty feet separated the new addition from the property lines at the north and west. An original shed at the northwest corner of the lot remained unaltered (Sanborn Fire Insurance Map, 1889, 1895).

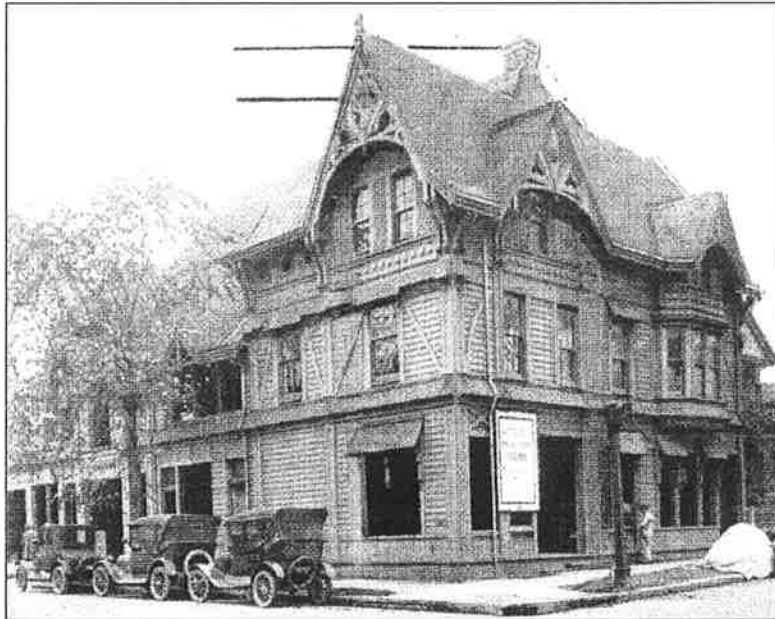
Image 5. 1926 photograph showing Ladd Carriage House remodel work.
Source: *The Oregonian*.
