# Erb Memorial Union Preliminary Historic Assessment

University of Oregon  
Campus Planning and Real Estate

December 2011

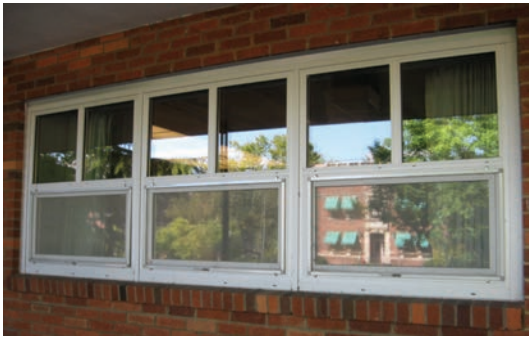
All north-facing windows in the Walnut Room were replaced in 2009. A wider opening was cut for windows, date unknown.

**Date Unknown:** The original window openings of the Walnut Room were expanded from individual to a set of three (refer to dwg #1). The replaced windows match the original double-over-single type.

**2009:** All windows of the Walnut Room were again replaced to match the existing window function, rail width, mullion size, and location. The main door was replaced with a single swing.

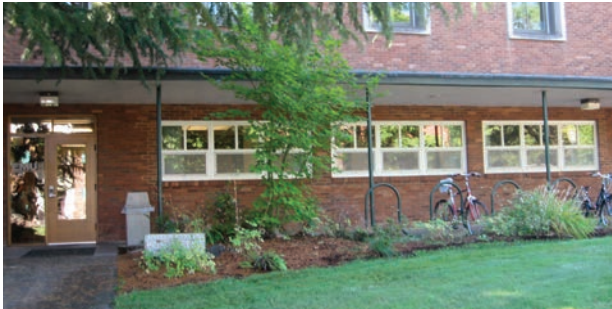
Original opening for Post Office double-swing door, replaced in 2009 with a single swing door.

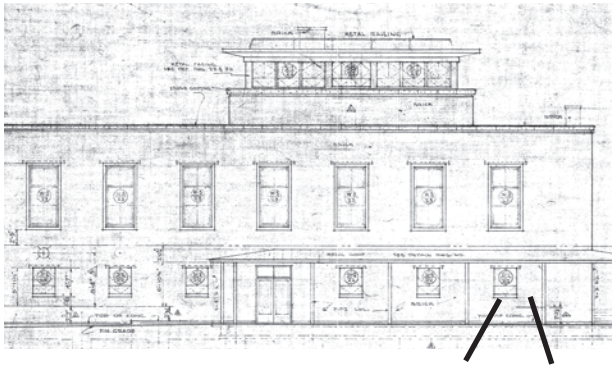
Dwg #1: Original Elevation c. 1948 showing original size of first-floor windows (single wide).

Original openings expanded, date unknown.

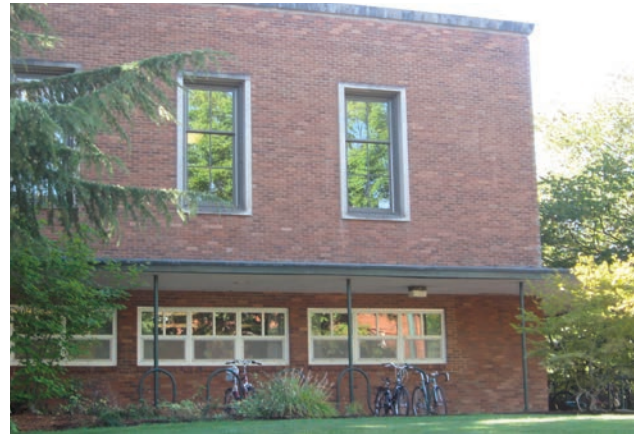
Second-floor windows all replaced in 2007.

**Level of Historic Significance:** high  
**Integrity:** excellent  
**Ranking:** primary

**Alterations:**  
**2007:** During a remodel of the Mills International Center, all seven windows on the north facade and the single window on the west facade were replaced with a wood assembly, profile to match existing wood windows (refer to diagram). On the interior, the existing trim was reinstalled.

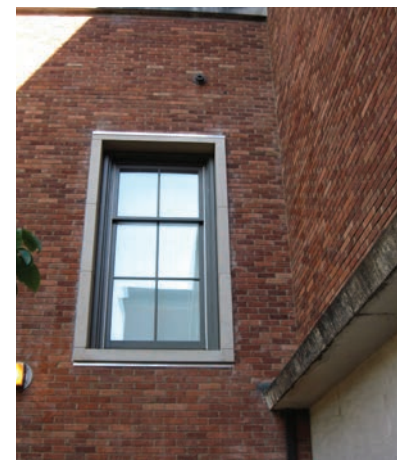
New opening for a window cut in south-facing wall to match existing during 2007 remodel.

On the south-facing facade, a new opening was made for an additional window. New interior trim, specified to match existing trim, was installed.

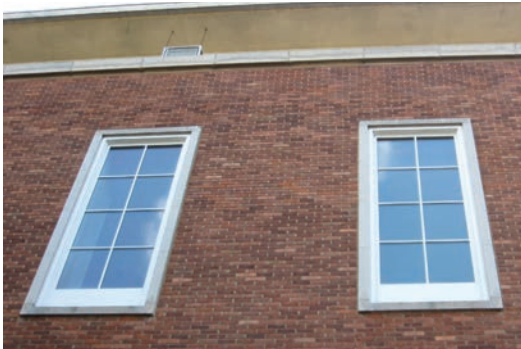
Second-floor windows had glass replaced in 2009; original wood frame & mullions.

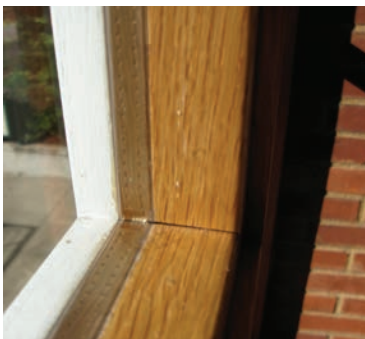
Detail of routing to fit second pane of glass in original hardwood windows.

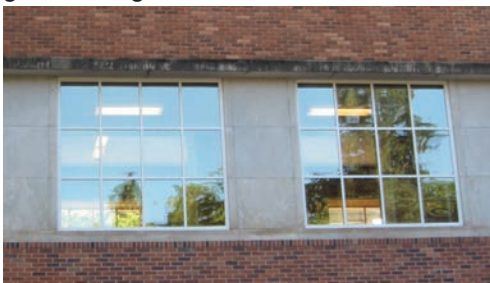
First-floor windows, glass replaced in 2009.

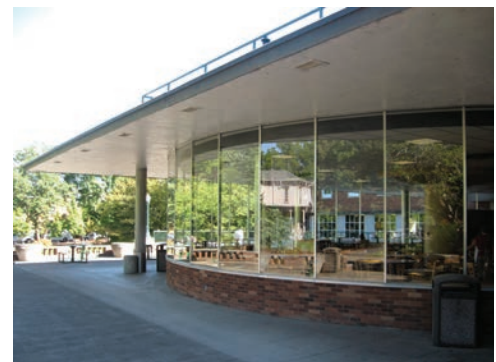
Original storefront system of Fishbowl.

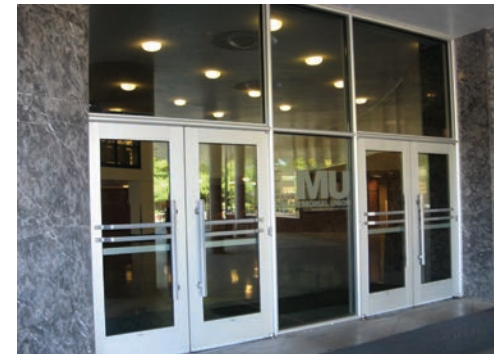
Main Entrance doors & windows replaced in 2009, maintaining hardware.

**2009:** Main entrance storefront system doors and windows were replaced, maintaining original hardware.

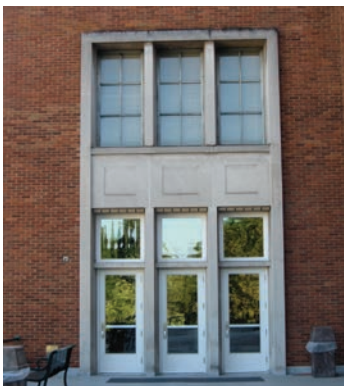
(1.) Replacement doors & hardware in 2009. Original cast concrete detailing & upper level windows.

**2009:** Single-pane glazing was replaced with double pane on ballroom windows on the west facade. The existing doors and hardware were replaced. Main doors from the balcony to ballroom lobby were replaced.

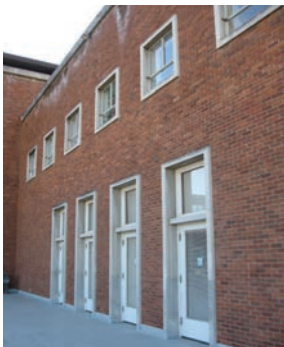
(2.) Three original balcony doors, with far right door retaining original hardware.

**1985 Addition:** An addition was built, altering the original west facade. Seven double doors on the west wall, opening out onto the terrace. These were labelled E1-E7 from south to north on the 1948 drawings. During the 1985 remodel E3 and E7 were replaced with new double doors. All other double doors were replaced with double-over-double windows. One opening for original double doors was infilled. Doors from the Gumwood Room opening onto north balcony had hardware replaced, with the exception of one door on the far west edge which retains the original hardware (refer to image #2).

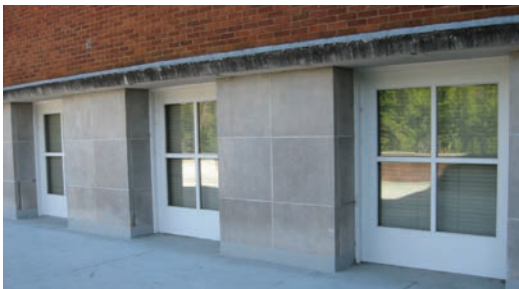
(3.) Three sets of double doors replaced by double-over-double windows in 1985.

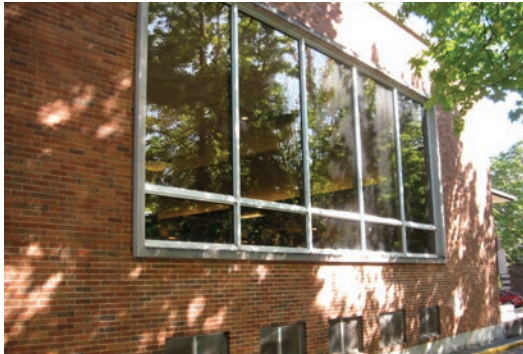
South Dining storefront windows replaced in 2009. Original vent openings below to basement.

**2009:** The original 1960 drawings of the South Dining windows were specified with  $\frac{1}{4}$  inch thick grey glass. This was replaced with 1 inch protective glazing and aluminum stop matching original height, width, and finish. The South Entrance doors were replaced, maintaining original aluminum storefront system and glazing surrounds. East-facing windows of the first-floor offices were replaced to match original double-over-single hung windows, but double glazed (refer to third photo).

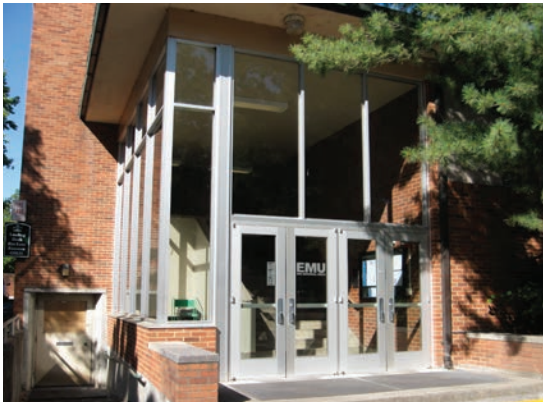
South Entrance aluminum storefront system replaced in kind in 2009. Original 1962 brick & limestone walls.

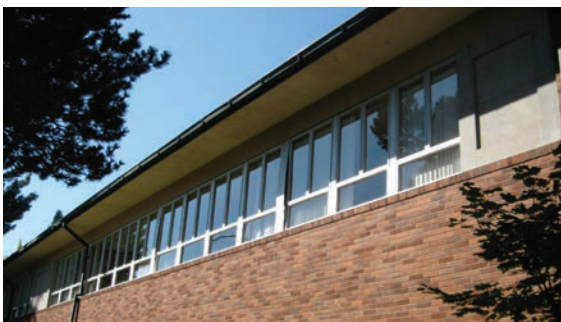
East-facing office windows replaced in 2009, with original stone panels (top right).

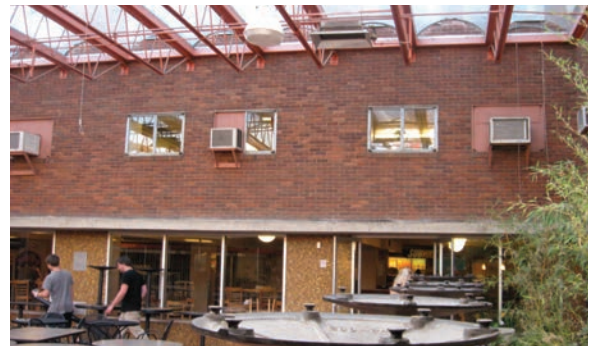
Original west wall made interior courtyard during 1962 addition.

**1962 Addition:** Widened openings for windows and doors on the first floor replaced original windows when the addition turned the space into a courtyard. Mosaic tile was added on top of existing stone on bottom portion of the west wall. Fixed windows on the west facade, with the exception of two, were replaced by sliders. On the south-facing facade, all but one fixed window were replaced by sliders, and vents were installed. The window on the far south end of the west wall was infilled with brick veneer to match original.

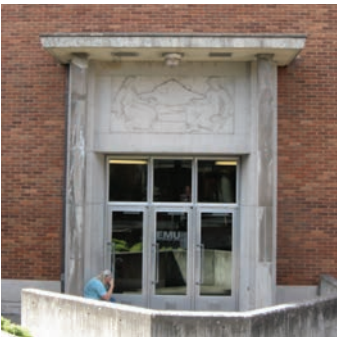
Original opening & engraving of East Entrance w/steel door and window replacements in 2009.

**2009:** The East Entrance door frames and glass were replaced with a steel storefront system. Original concrete canopy and sculptured panel remain.

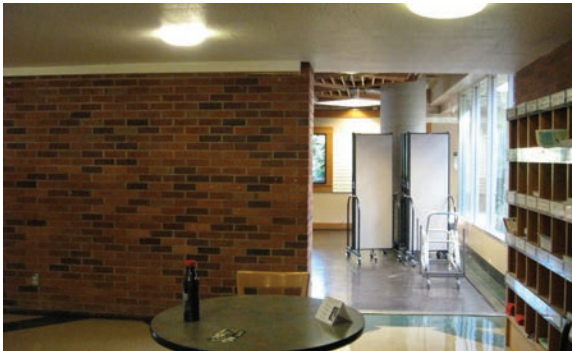
One of three openings in lobby cut in original exterior wall to make way for 1973 skybridge.

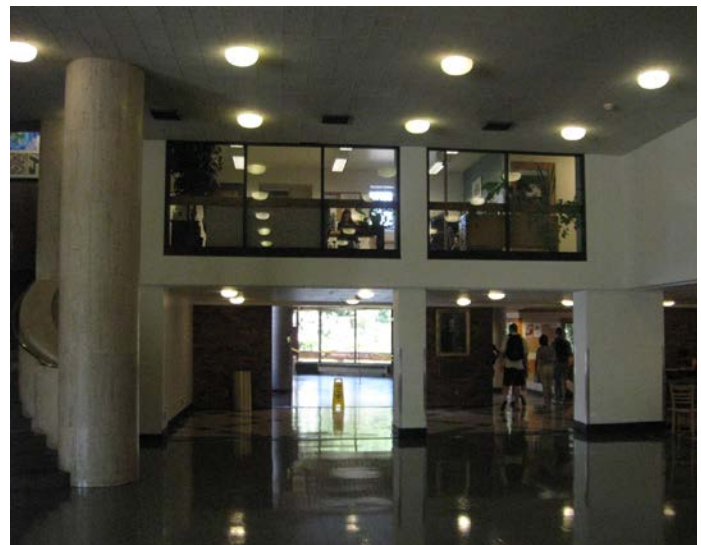
Looking east to 1970s addition - Mezzanine storefront windows added.

**1973 Addition:** Openings for storefront windows were cut out of the mezzanine wall.

**2009:** Storefront system was replaced, maintaining original door hardware.

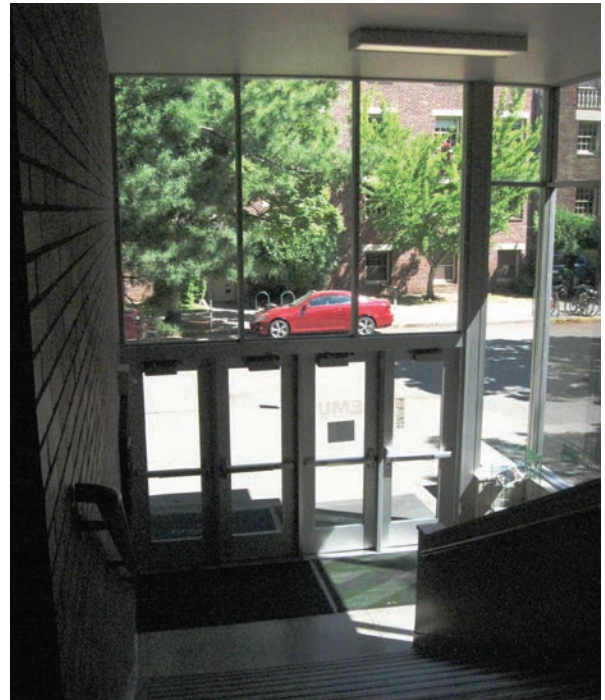
South Entrance Stair, original windows & aluminum storefront.

**2009:** All doors were replaced, maintaining original surrounds.

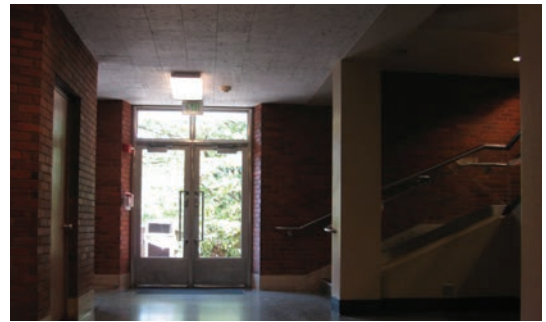
Glass panes in doors replaced in 2009 (looking west).

**2009:** Glass panes in the west doors to the exterior were replaced with similar style.

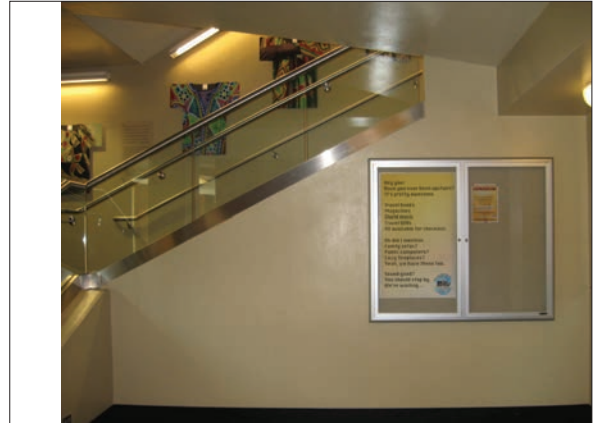
New handrails installed in 2000 Mills International Center remodel (looking north).

**2000:** The stair handrail was replaced as part of the Mills International Center Remodel. Elevator addition at this time installed a new door on the east wall.

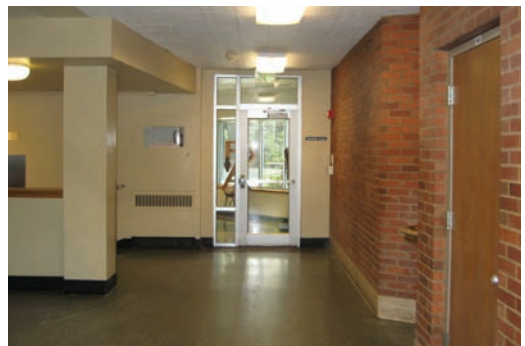
Doorway to elevator addition of 2000 (looking east).

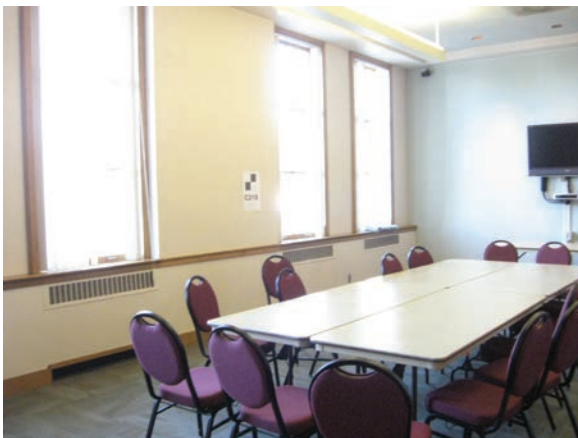
Single pane glass replaced with double pane in 2009.

**2009:** Single-pane glass in the windows were replaced, hardwood frames preserved.
