National Register of Historic Places Registration Form

historic name The Roba Ranch

city or town Paulina

county Crook

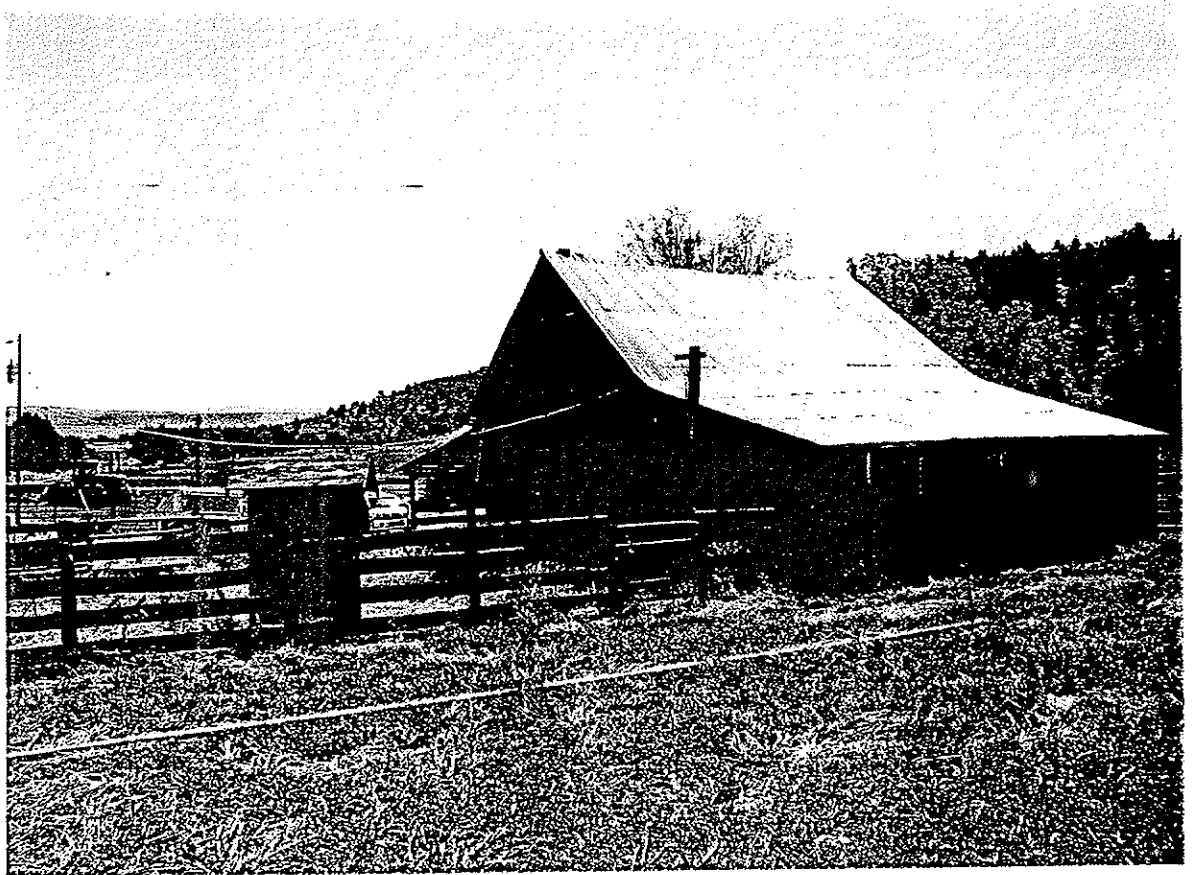
- 14 of 22: Exterior View: barn, north and east facades, looking southwest
- 15 of 22: Interior View: barn interior construction, looking east
- 16 of 22: Exterior View: privy, south and east facades, looking northwest
- 17 of 22: Exterior View: pump house, south and west facades, looking northwest
- 18 of 22: Exterior View: corral and fencing, looking west. Notice the series of rock cribs and rock backs to the right.
- 19 of 22: Exterior View: non-contributing machine shop, north and west facades, looking southeast
- 20 of 22: Exterior View: non-contributing equipment/vehicle storage building, north and east facades, looking southwest
- 21 of 22: Exterior View: non-contributing barn, south and east facades, looking northwest
- 22 of 22: Contextual view of the Roba Ranch looking southeast

The oldest building on the Roba Ranch is the log-framed, broken-gable roof barn built in c. 1888/89. The 52 by 26-foot building originally had a wood shingle roof, but is now covered with corrugated metal. The barn sits on a knoll over 180 from the east side of ranch house and is clad in rough-sawn, vertical wood-board siding. The vertical boards are random in widths of 6, 7 ½, 8, 10, 11, and 12-inch wide by one-inch thick boards. The barn foundation, hand hewn 14 by 14-inch, squared timbers with rounded corners, sits on tuff stone blocks. The timbers appear to be notched by hand. The south side of the barn has a shed roof lean-to that is open on three sides.

The barn interior is all open space with a dirt floor except for the north end that is walled off to enclose a chicken coop and storage area. This section has a wood-plank floor. Interior beams are hand hewn 8 by 8 ½-inch, 6 ½ by 6 ¾-inch, or 9 ¾ by 9 ¾-inch timbers. The south side of the barn has a wood feed trough separating this area from the covered saddle area. Some repair has been done to the barn, namely a corrugated tin roof.
