# STRAUB HALL INTERIORS PRELIMINARY HISTORIC ASSESSMENT

CAMPUS PLANNING AND REAL ESTATE - JANUARY 2011

This assessment identifies Straub Hall's historically significant interior finishes, features, and spaces.

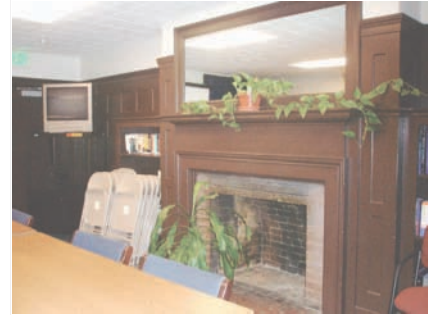
**Historic Materials:** One-half of the entry archway, all window casings, the fireplace and its mantle, built-in shelving and wood paneling.

^ FIREPLACE CONTEXT.

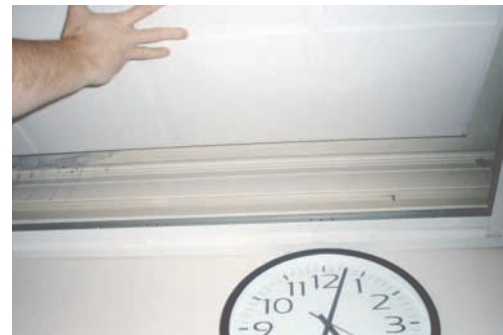
The ceiling was lowered using an acoustical tiling system. The original wood picture rail moldings at the original ceiling height are evident above the ceiling tiles along the north wall.

^ ORIGINAL WOOD TRIM ABOVE THE CEILING TILES.

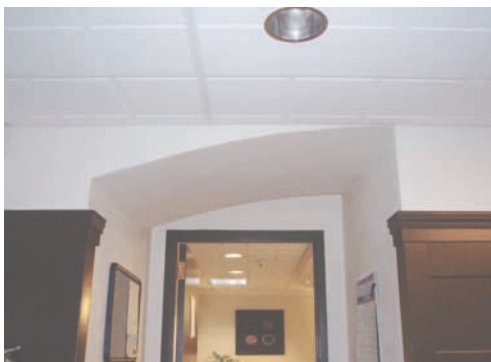
**Alterations:** The south half of the archway was filled in to allow for new standard 3' doors on the exterior and interior entrances. Carpeting was installed (it is unclear if the original taupe linoleum flooring remains underneath). All window casings, the fireplace, and the wood paneling on the walls are original but have been refinished and painted throughout the years. Some wood paneling has been added and made to look original.

^ ENTRY ARCHWAY.

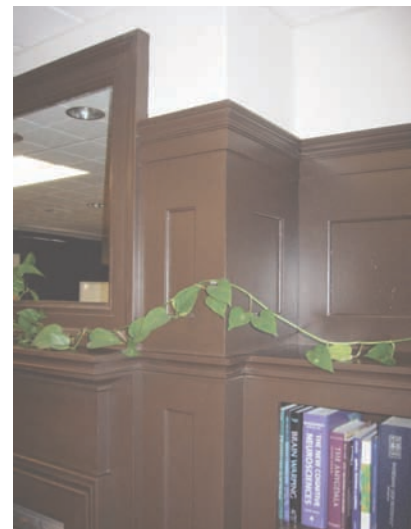
^ WOOD PANELING.

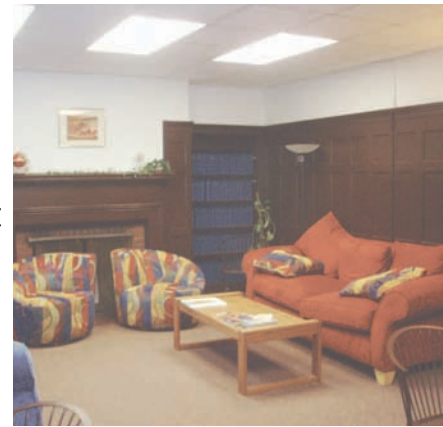
^ FIREPLACE CONTEXT.

**Historic Materials:** Most wood paneling, fireplace, built-in shelving and ceramic tile entrance, as well as what remains of the entry archway and ceiling moldings (hidden).

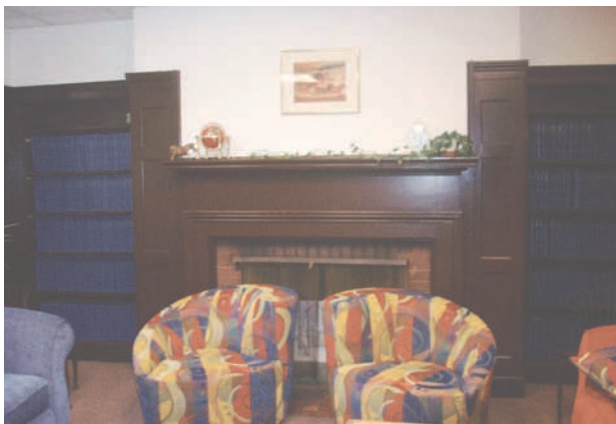
^ FIREPLACE AND BOOKSHELVES.

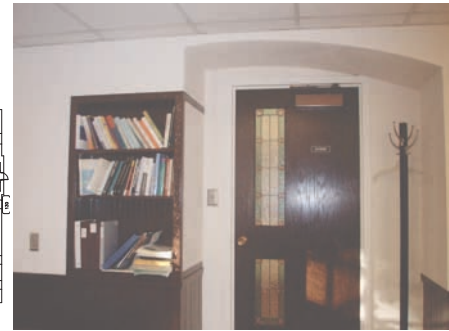
^ ENTRY ARCHWAY.

**Alterations:** Half of the archway was filled in, and the room was divided into two spaces.

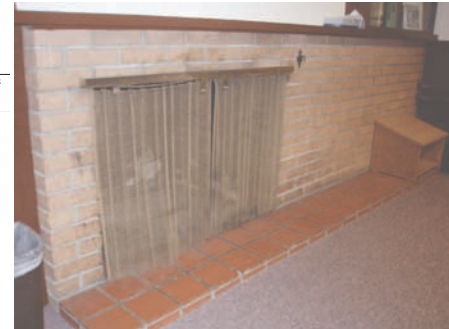
^ FIREPLACE.

All of the wainscoting, doors, and hardware have been replaced. Also, the bricks surrounding the fireplace and the terra-cotta tiles are thought to be of a different era.

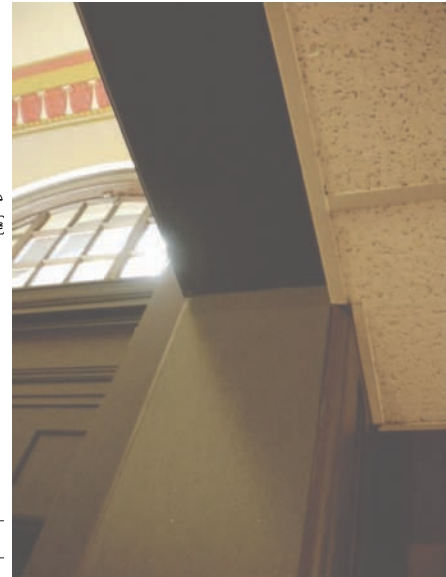
^ CEILING DETAIL.

The original ceiling was covered by an acoustical suspended tile system. In 1974 an elevator was added between two existing structural columns, which were maintained.

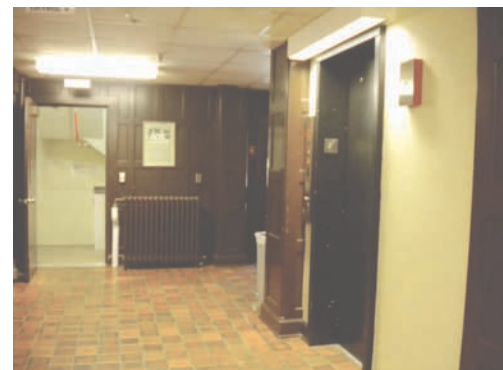
^ HALLWAY ELEVATOR.

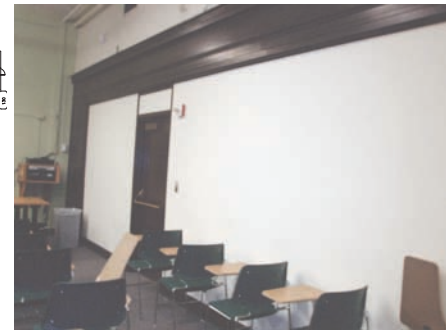
^ NEW SOUTH WALL.

The wall that splits this space in two is new, as well as the infill of a window in room 143 on the north wall due to the addition of a space on the other side of the wall (Earl Hall). The newer panelling used to fill the original window in this room is evident due to the drastic change in the inset panel squares.

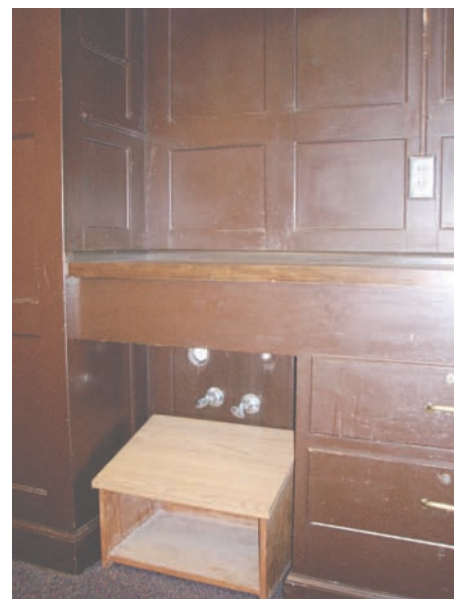
**Historic Materials:** The north wall wood paneling in room 142, as well as the window casings. The wood paneling in room 143 and the cabinets as well has hardware in niche on the south wall, which was originally used for a sink station.

^ FORMER SINK STATION.

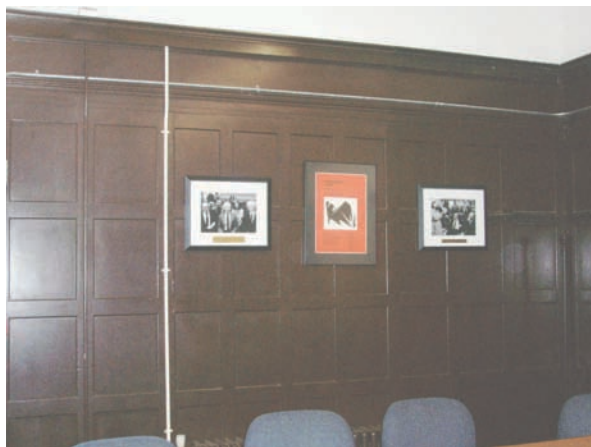
^ FILLED WINDOW.

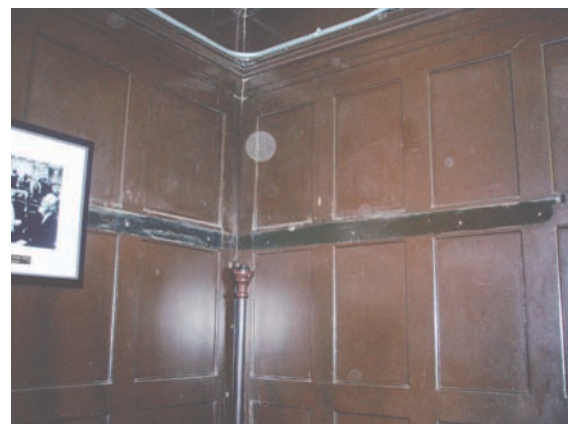
^ REMAINS OF CORNER SHELF.

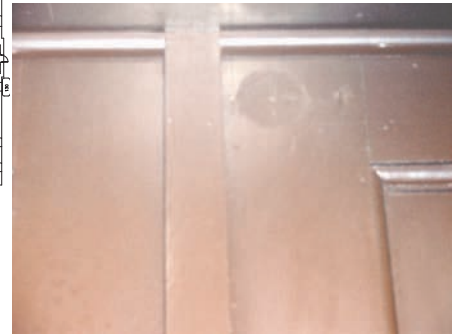
^ BATON AND BUMPER SCAR DETAIL.

The paneled walls of this space are the original accordion walls. They have been fixed into place and the joints have been covered with battens. The original scars from the bumpers and the walls scraping against the moldings are still visible on the accordion panels.

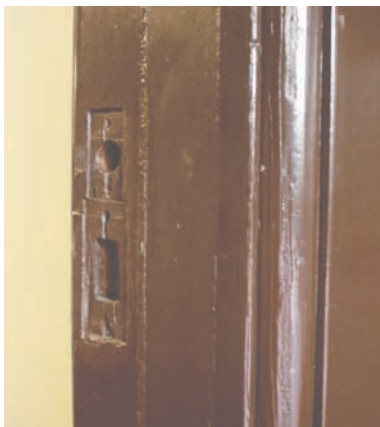
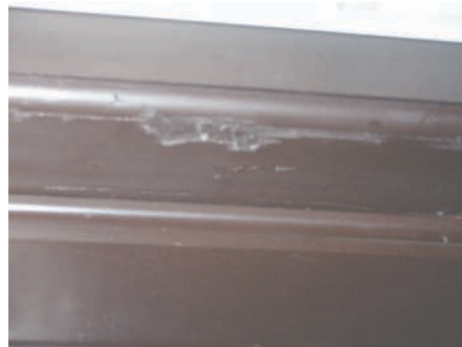
< WALL SCAR DETAILS. ^

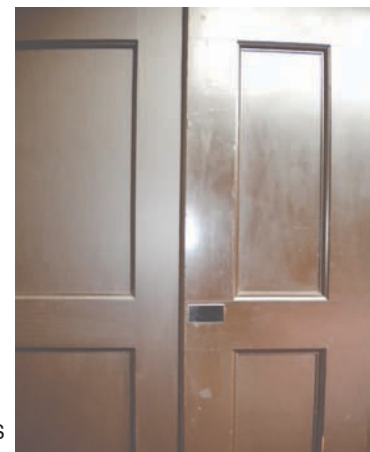
EXAMPLE OF DIFFERENT FINISHES  
(NEW VS ORIGINAL). >

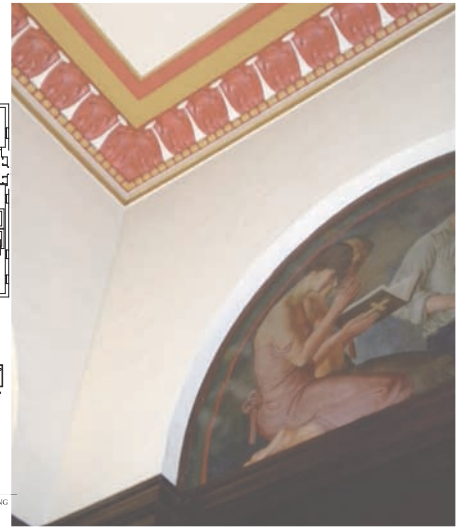
^ CEILING AND MURAL DETAIL.

**Historic Materials:** Wood paneling, trim, and doors on north, south, and entry walls, entry door openings, canvas lunette murals by K. E. Hudson, decorative cove molding, ceramic tile flooring, and lighting hardware.

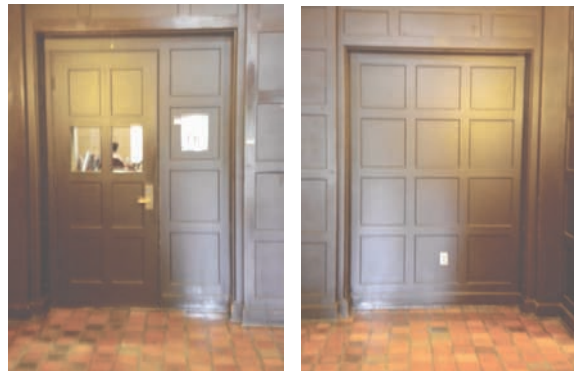
The east wall was originally the entrance to the dining hall, which mirrored the main entrance to the building with three sets of double doors. In changing this room to a lecture hall, the entries were sealed. The infills were designed to match the existing columns, creating a seemingly original wall. Sitting here, too, is a bust of John Straub, in memoriam.

^ EAST INFILLS. ^

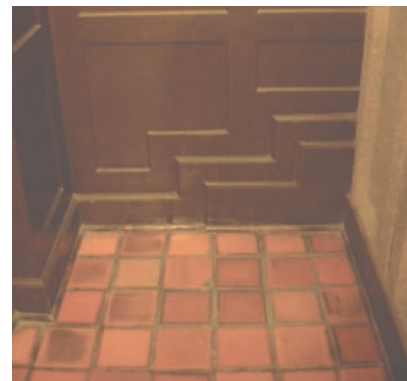
The original stairs were removed to add a ramp, making the Straub Hall lobby ADA compliant. The ramp is the most noticeable change in the space, since it clearly is not part of the original design. The baseboard that originally lined the stairs can still be seen.

The wood paneling and tile were patched and retouched throughout the years, though the original finish can be seen on the south side of the west wall.

^ STAIR BASEBOARD AND TILE DETAIL.

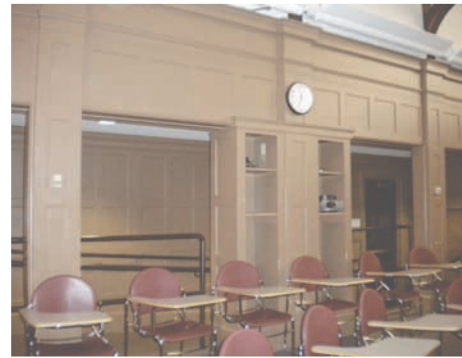
^ WEST WALL AND ENTRY/FOYER, 2010.

The main entry/foyer on the west wall was altered for ADA compliance in 1974. A ramp and new stairs were added to the foyer. The built-ins that now stand with the foyer columns were added when this room was converted into a classroom, as was the tiered/stepped floor for enhanced seating. Carpeting was installed. It is unclear if the original clear maple flooring remains under the carpet. Salvaged quarry tile from the lobby was used at the entries.

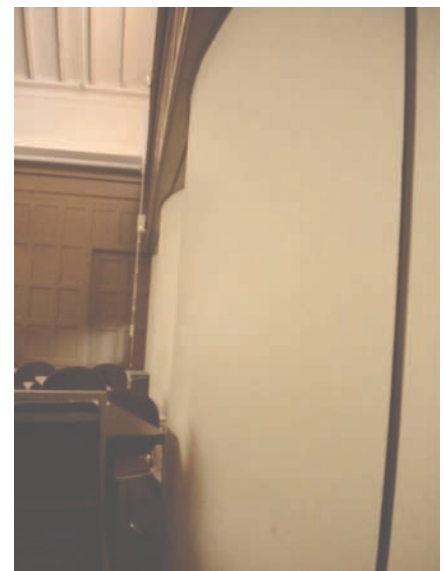
^ SOUTH WALL - ACOUSTICAL PANELS.

An undulating acoustical wall covers the original accordion walls fixed in-place at the north and south ends of the room. The original wood paneling above the accordion walls was retained as a border. Above this a few rows of acoustical tiles were added.

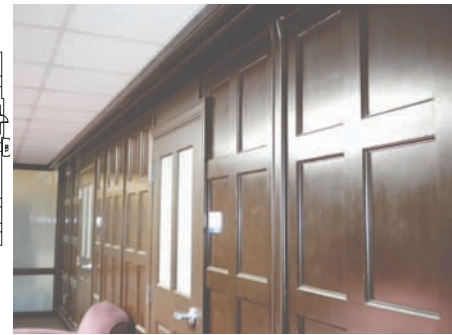
^ WALL DETAIL - NEW PANELING.

Again, the panelling that you see is the original folding wall. When the battens are removed, the sections (complete with hardware scars) are visible.

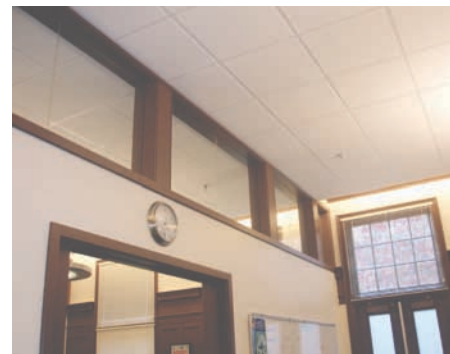
^ NEW PARTITION WALL.

**Alterations:** Originally this space was one large room with a smaller room at the back (156D). The large room has been split into three rooms with the fourth still at the back. The partition walls, moldings, ceiling tiles, and carpeting all are new. Also, the original north accordion wall, which can be seen from the hallway, was modified to accommodate two new doors. The ceiling was lowered a significant amount to hide HVAC units above. Carpeting was installed in 154, 155, and 156B (originally clear maple flooring), and in 156D (originally grey linoleum). It is unknown if either original flooring materials remain under the carpet.

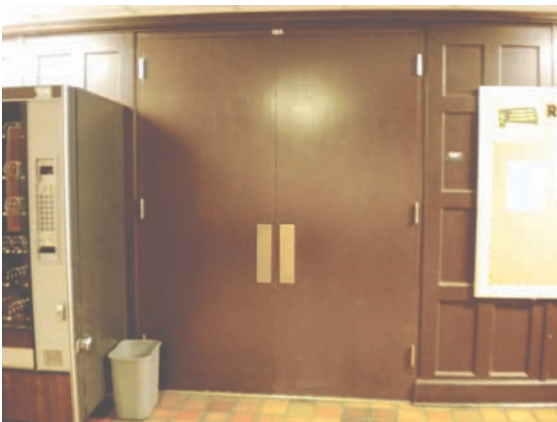
^ ROOM 154 - NEW (UNUSED) DOORS.

The east wall’s material and double doors are not original but were added in the 1974 remodel and have been preserved since then. A door to what was a trunk room (now a collection of small offices and subject run rooms) has been sealed, but the molding remains. The doors throughout the space are all different, only one being the original style (north of the skylight, first door to the east).

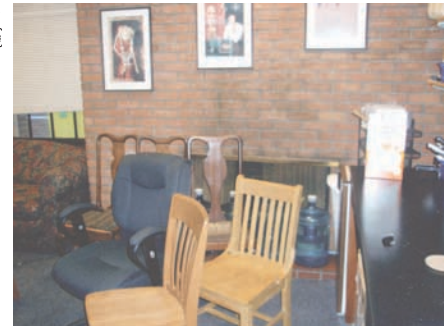
^ FIREPLACE CONTEXT.

**Alterations:** This room has been divided into two rooms, bisecting the fireplace's tiles. The bricks surrounding the fireplace and the wainscoting have been replaced, along with the addition of the office door. The ceiling tiles have been glued onto the original ceiling; no moulding remains.

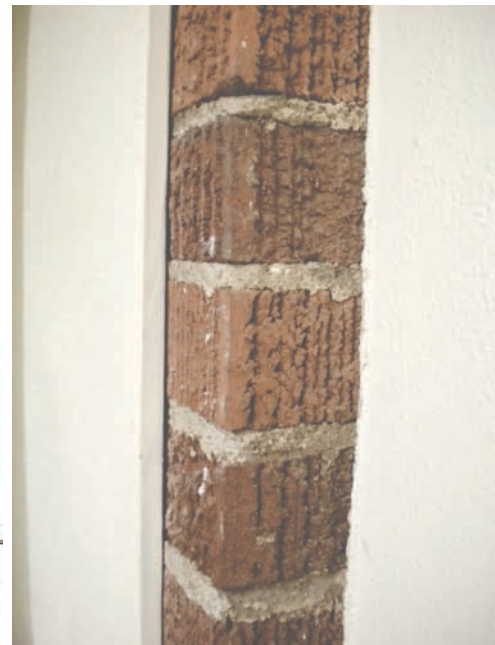
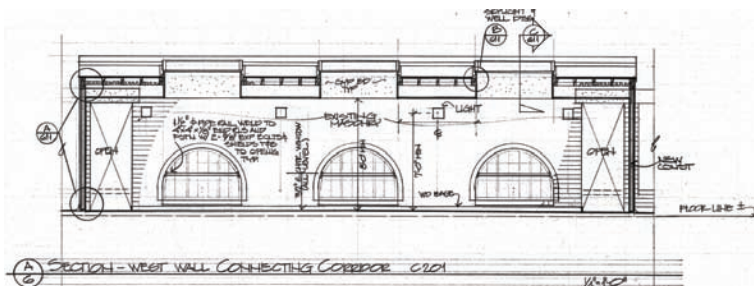
^ SECTION - WEST WALL CONNECTING CORRIDOR, 1974.

**Alterations:** This space was not part of the original design. When the connecting corridor was added the west wall, which is the upper portion of the main lobby, was preserved. However the north, south, and east walls (as well as the ceiling and skylights) all are new construction from 1974.

The only alterations to the west wall seem to be the additions of the steel piping across the windows, baseboard heaters, and the electrical light fixtures.

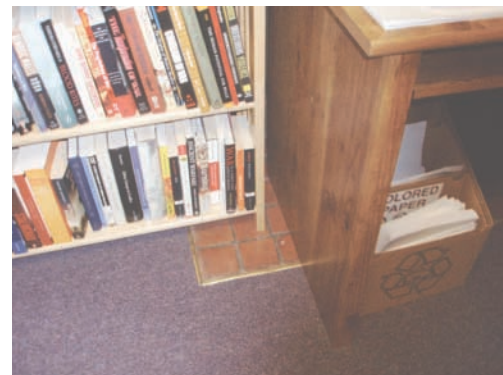
^ FIREPLACE TILING DETAIL.

**Alterations:** The space was divided into three offices. All wall, floor, and ceiling finishes were altered. The fireplace's brick and tile work may have been removed and replaced.

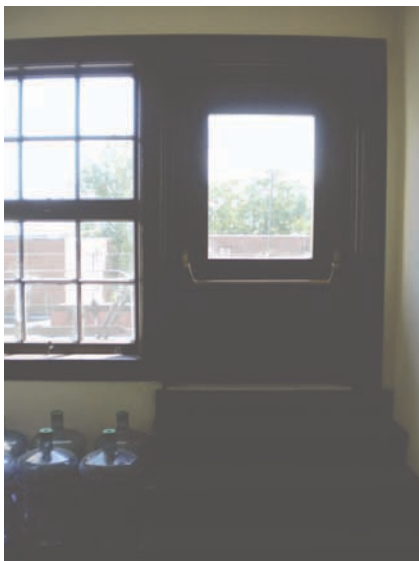
^ NORTH HALLWAY 4TH FLOOR FIRE ESCAPE.

**Alterations:** All exposed piping, electrical, and mechanical units were added, as were fire doors and a fire escape door. In 1984 new carpeting was installed. It is unclear if the original taupe linoleum remains under the carpet. A few doors have been replaced as well (see *North Hallway 4th Floor New vs. Old Door*).

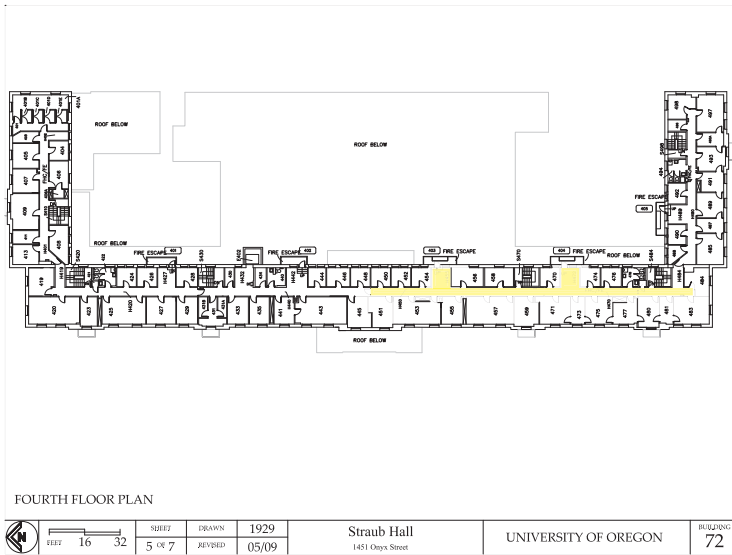
^ SOUTH HALLWAY 4TH FLOOR.

**Level of Historic Significance:** Low  
**Integrity:** Good

**Historic Materials:** Window and door casings, most doors and walls, the fire escapes, telephone niches, and ladders.

**Alterations:** All exposed piping, electrical, and mechanical units were added, as were fire doors and a fire escape door. The fire escape ladders are original but have been moved from their original locations. In 1984 new carpeting was installed. It is unclear if the original taupe linoleum remains under the carpet.
