National Register of Historic Places Registration Form

1. Name of Property			
historic name Hobson-Gehlen General Merchandise S	store		
other names/site number			
2. Location	1		**************************************
street & number 189 N. 2 nd Avenue		no	ot for publication
city or town Stayton			cinity
state Oregon code OR county M	larion code _	047 zip code	97383

Hobson-Gehlen General Merchandise Store

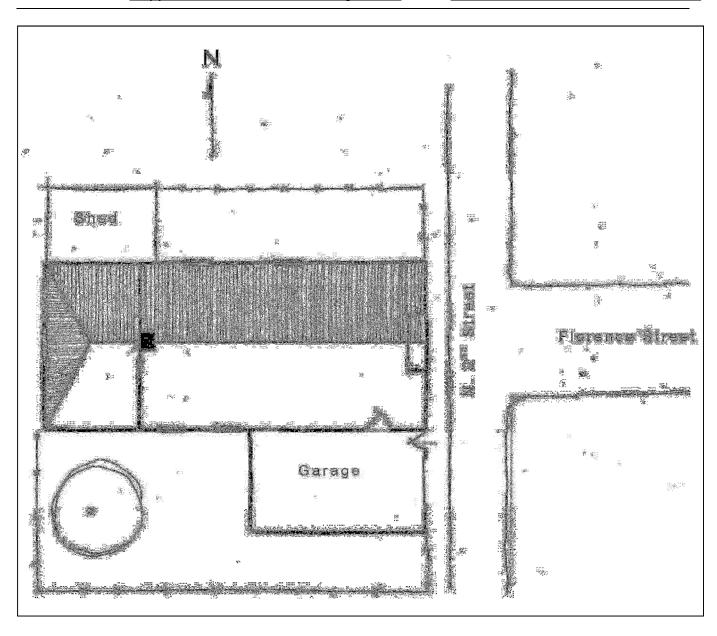
Figure 5. Site plan of Hobson-Gehlen General Merchandise Store. Drawing by author.

As a typical commercial building of its period, the main two-story volume of the Hobson-Gehlen Store is rectangular in shape, measuring in total approximately 27 feet wide along the street front and 69 feet deep. (Figures 3 and 5) Resting on a concrete and wood timber foundation, the balloon-framed walls rise two full stories, and the front-gable roof is clad in corrugated sheet metal. Originally designed with a false-front, that feature was removed in 1963 revealing the building's front gable roofline. The front (east) facade now displays a pent roof above the historic wood-framed storefront. (Photos 1, 4-6) Rising from the roof peak at the eastern end of the building is a simple red brick chimney that historically serviced a wood stove.

The current footprint of the building appears very much as it was drawn on the 1931 Sanborn, with the exception of the two small projections at the northwest rear corner, which have been replaced with three larger open sheds. (Figures 4, 5 and 7; Photos 5 and 10)

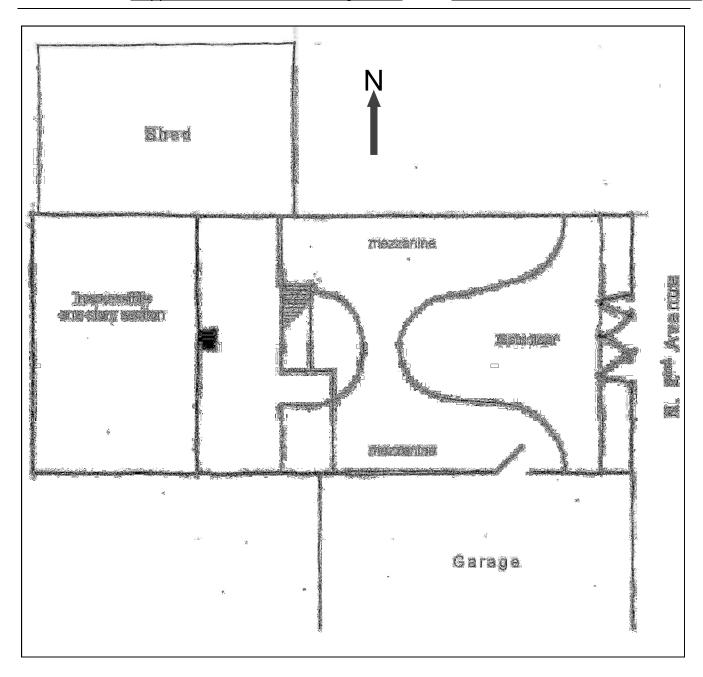
Figure 6. Floor plan of Hobson-Gehlen General Merchandise Store. Drawing by author.

The interior of the building is divided into front and rear spaces, the front (east) one-half of the first floor being the public mercantile section, and the rear (west) half housing administrative and residential space. (Figure 6) Access to the garage addition to the south, historically through a wood five-panel door that remains in place, has been blocked by merchandise display cases. A wider opening along the south wall, historically providing access to the one-story south side addition, has been infilled and faced with wide horizontal boards. The display areas flanking the front entrance continue to be used for merchandise display.

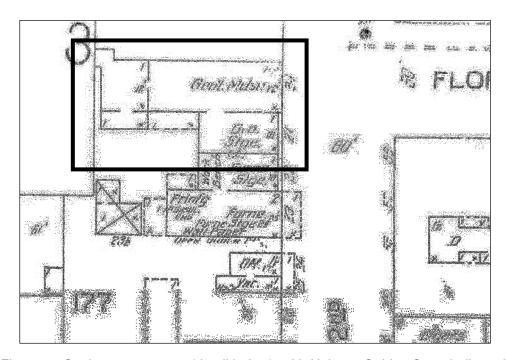
Figure 7. Sanborn map, 1913 (detail below), with Hobson-Gehlen Store indicated.

Originally the Hobson-Gehlen Store appears to have been constructed as a single, two-story volume with a one-story extension to the rear (west). An addition to the south side is evident on Sanborn maps of 1913 and 1931. The original central entrance doorway was widened slightly to accommodate an automobile entrance, though the actual bay width appears unaltered. This change likely occurred in the mid-1920s, a theory based on the design characteristics of the current doors coupled with the building's ownership history; it also corresponds to the shift from mercantile to auto-related use after 1924. The newer rolling overhead door installed on the interior of the building at this central bay provides security and allows the original paired doors to remain in place. When open, the overhead door is minimally visible from the exterior, though it does block the center-bay transom lights from the interior. The original false front with bracketed Italianate cornice remained in place until about 1963. Some minor changes were made to the storefront detailing at an unknown date.

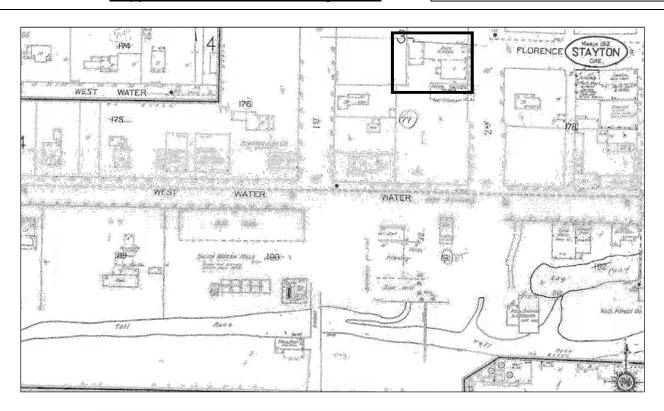
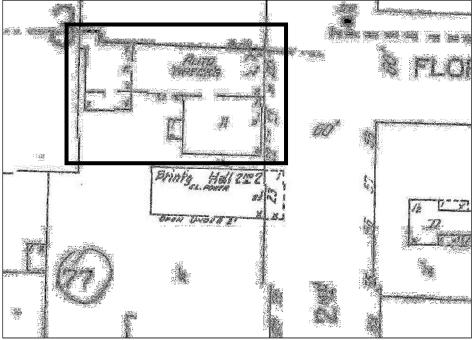
Figure 8. Sanborn map, 1931 (detail below), with Hobson-Gehlen Store indicated.

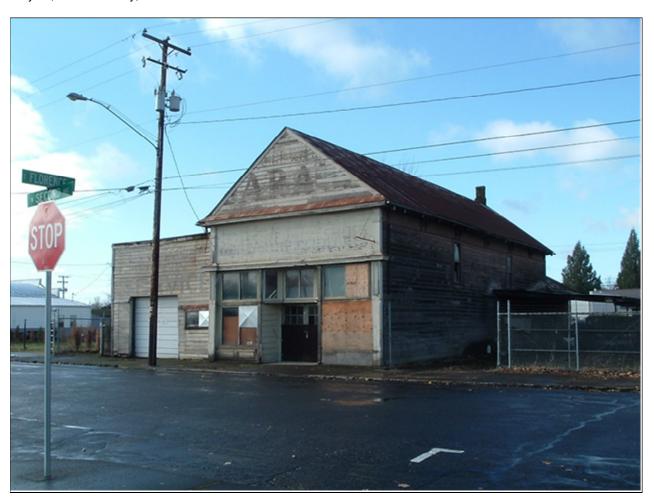
Photo 1 of 16. Marion County Assessor photograph, looking southwest showing remnant historic painted signage. Courtesy Marion County Assessor, http://apps.co.marion.or.us/PropertyRecords/

On the other side of the two-story volume, at the rear of the north facade, are three contiguous open sheds attached to the store building, both of which are modern additions. (Photos 1 and 10)

The "cornice" above the transom historically divided the storefront from the solid false front that was removed around 1963, thus exposing the gable end and forming a pent roof.⁴ This feature was and is essentially a continuation of the eave line that exists along the north and south side elevations. With the front gable exposed, it now reads as a pent roof. Both the front and rear gable ends appear to be covered with the same 7½-inch shiplap siding found on the lower side walls. Early painted signage located on the front (east) gable end has been painted over. (Photos 1, 2 and 6)

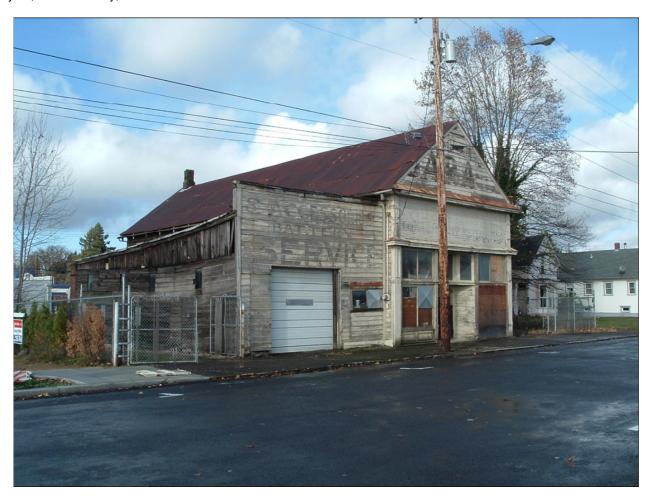
Photo 2 of 16. Marion County Assessor photograph, looking northwest showing remnant historic painted signage. Courtesy Marion County Assessor, http://apps.co.marion.or.us/PropertyRecords/

Immediately to the south of the two-story primary volume is a rectangular one-story garage, possibly built sometime between 1908 and 1913.³ (Photos 2, 5, 7-9) Measuring approximately 22 feet along the street by 40 feet deep, this smaller wood-framed building has a post-and-pier foundation of wood, balloon-framed walls and a shed roof sloping down from the false front facade toward the back. The structure is minimally connected to the Hobson-Gehlen Store via a ledger attached to the south exterior wall of the store's two-story volume. A garage bay faces the street, and an interior door once provided access between the garage and store buildings. Although it appears to retain relatively good historical integrity, due to deterioration and the weight of a late snowfall in the winter of 2012, this building is in poor condition with a partially collapsed roof and failing floor structure.

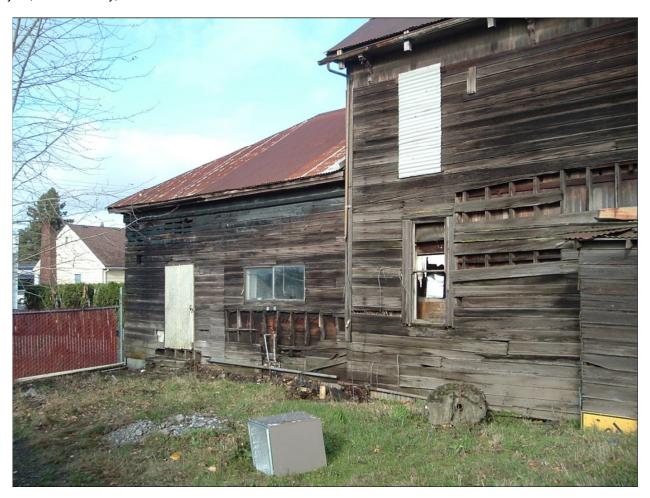
Photo 3 of 16. Marion County Assessor photograph of west end of south side facade, one-story rear extension. Courtesy Marion County Assessor, http://apps.co.marion.or.us/PropertyRecords/

A one-story volume extends from the back (west) end of the building approximately 26 feet. (Photos 3, 5 and 10) This section appears to be early, if not original, construction also balloon framed, and has a hipped roof. Having been damaged by fire at an unknown date some years ago, it is currently being repaired and updated with new vinyl windows and T 1-11 siding.

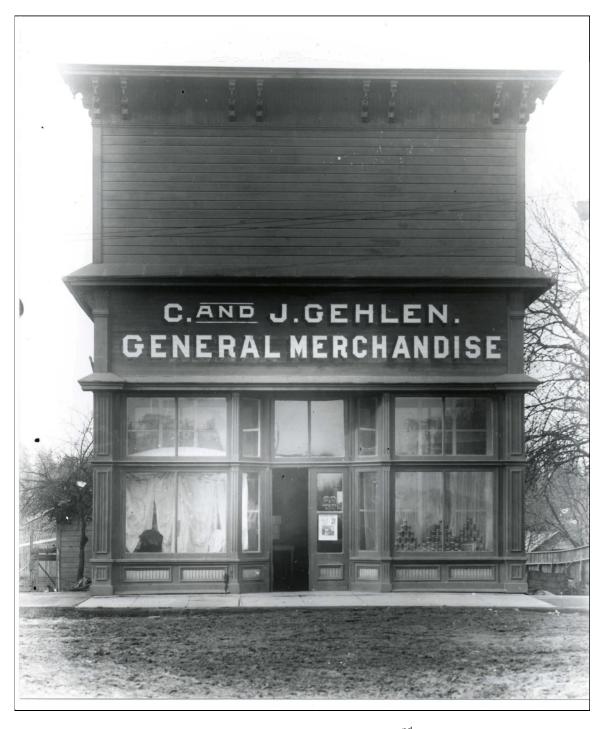
Photo 4 of 16. 1908 view of front (west) facade taken from N. 2nd Avenue and Florence Street. Photo by John Lau, provided courtesy of the Santiam Heritage Foundation.

suggestive of its probable 1920s vintage. After the Gehlens sold this building in 1924 to auto dealers Oliver Baker and William Ryan, the doorway in the central bay was widened from its original narrower configuration, presumably to accommodate the building's new use. A modern interior overhead door has been installed to provide adequate security while allowing for the retention of the original doors. The large, divided-light transom windows that span the width of the storefront above the display windows and entrance bay are original. The solid panel immediately above the transoms is covered in horizontal boards, and serves as the sign panel for the building as it did historically. (Photos 4-6)

The Hobson-Gehlen Store retains a high degree of integrity of location, workmanship, materials, feeling and association. The building's interior is particularly good, retaining integrity of design, workmanship, materials and feeling. In the area of design the building displays the subtle alterations made in the mid-1920s and as a result, clearly reflects its circa 1885 design and function as well as its auto-era, post-1920s appearance thus illustrating larger trends of commerce in the community (from small-scale mercantile to auto-related business). The store's immediate setting has changed due to the loss of many of the surrounding wood-framed buildings that were present in the nineteenth and early twentieth century. Although some of the characteristic features of the Hobson-Gehlen Store have been lost or removed - namely the false front and some of the storefront detailing - the building still conveys its early construction date and ongoing commercial function. Clear evidence of the lost design features and overall appearance remain in at least one historic photograph, and these elements could be accurately reproduced if desired. (Photo 4)

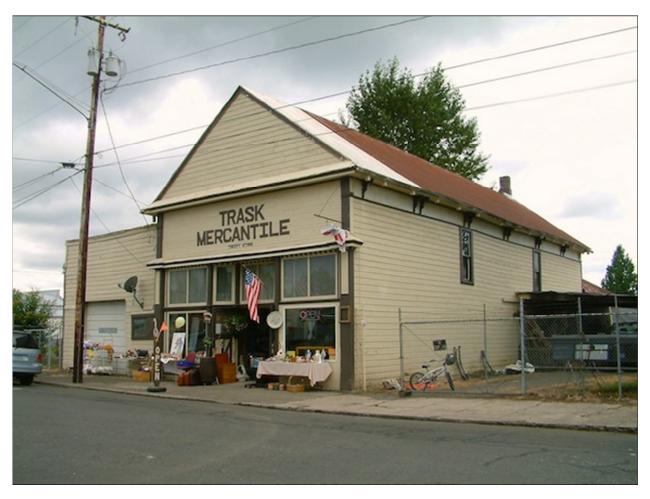
Photo 5 of 16. View of east (front) and north side facades from N. 2nd Avenue.

The two-story Hobson-Gehlen store building is constructed with balloon framing, studs placed 16 inches on center, and is clad on the north and south sides in 7½-inch shiplap siding fastened with cut nails. The shiplap siding truncates approximately 12 inches from the eave, at which point a frieze panel is delineated by a narrow, applied horizontal molding running the full length of the building. From this molding to the eave the frieze is further demarcated by the application of vertically applied 3½ to 4-inch V-groove boards. The approximately 12- to 14-inch overhanging boxed eaves are embellished with bed molding and decorative Italianate brackets arranged in pairs along the north and south sides of the building. (Photos 5 and 11)

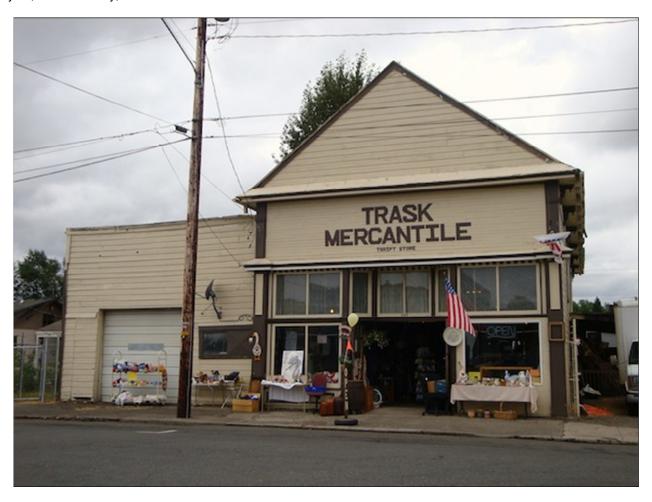
Photo 6 of 16. View of east (front) facade from N. 2nd Avenue.

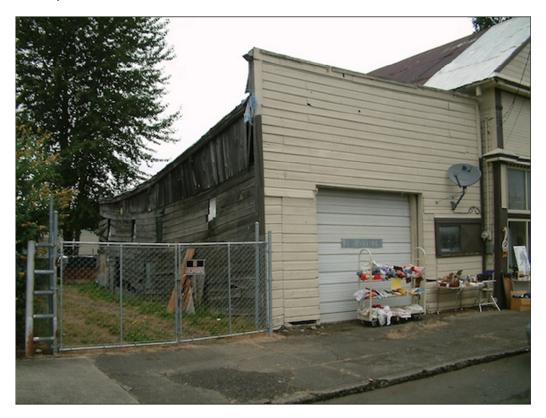
Photo 7 of 16. View of southeast corner of garage (facing northwest) from N. 2nd Avenue.

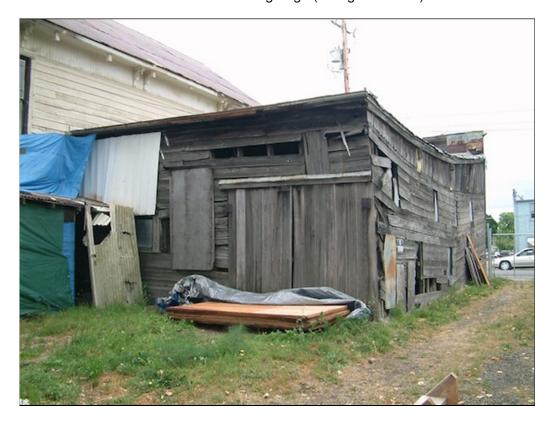
Photo 8 of 16. View of southwest corner of garage (facing northeast) from rear of lot.

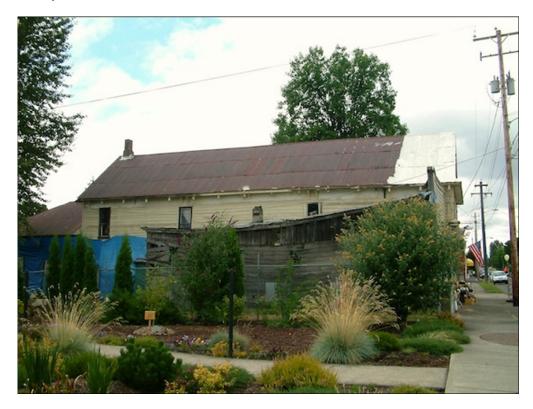
Photo 9 of 16. View of south walls of main building and garage from neighboring property.

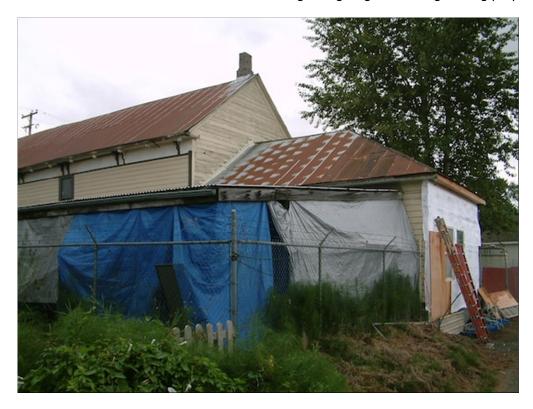
Photo 10 of 16. View of rear (north and west)portion of building (facing southeast) showing one-story rear extension.

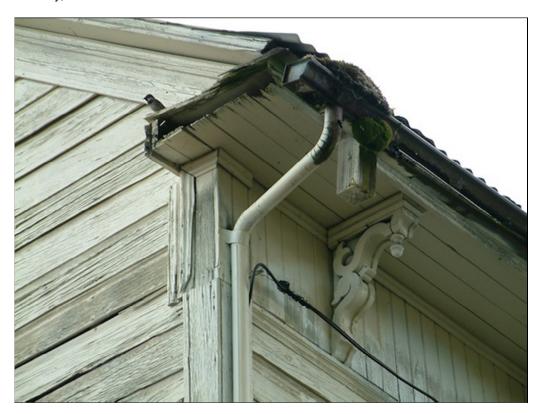
Photo 11 of 16. Detail of southeast corner at eave.

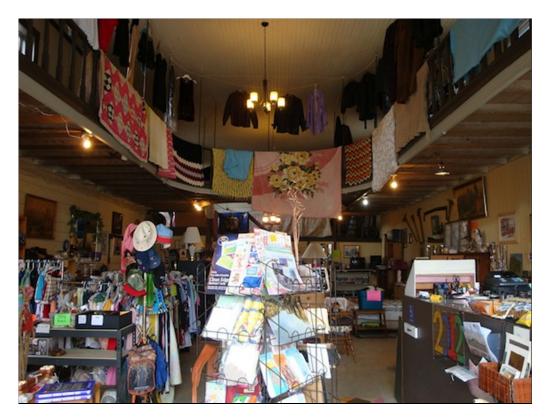
Photo 12 of 16. Interior view from front entrance, looking toward rear (west).

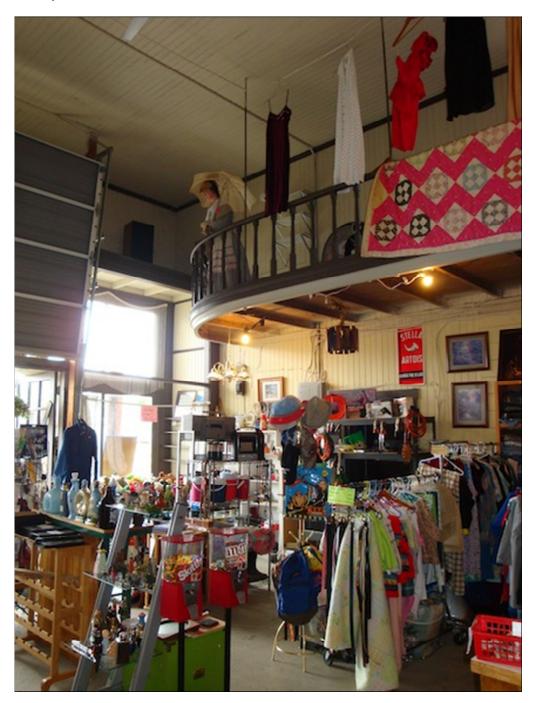
Photo 13 of 16. Interior view looking southeast; front entrance doors at far left.

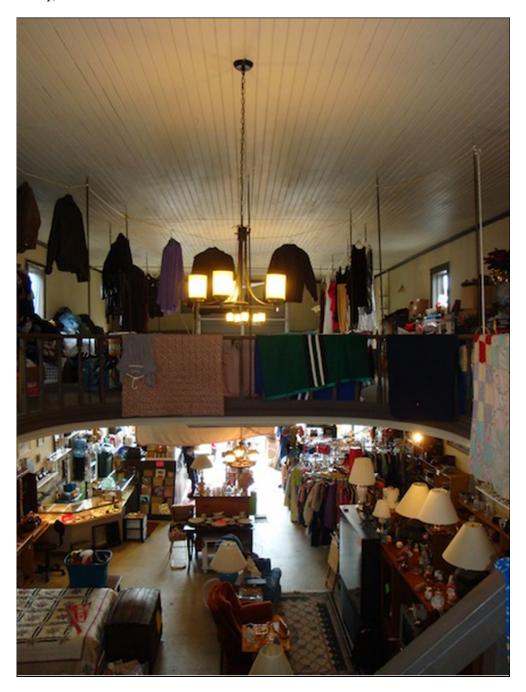
Photo 14 of 16. View of first floor and mezzanine from west end of second floor, looking east.

The second floor level is visually dominated by the mezzanine, an elegant curvilinear feature that sweeps into two mirrored horseshoe-shaped openings over the mercantile space. The framing, floor and railing of the mezzanine all appear to be original. (Photos 12, 13 and 16) The turned balusters and shaped handrail are particularly well-preserved. The far southwest corner of the mezzanine seems to have been truncated at an unknown date, likely to accommodate the current (newer) stair access. The original configuration of this corner section is not currently known. The rear portion of the upper floor is an open room (not part of the mezzanine structure) measuring 27 by 19 feet. (Photo 15) Floors throughout are fir tongue-and-groove. The ceiling is also covered in painted 4-inch V-groove boards. The entire upstairs area is currently used for storage. Storefront transoms and double-hung windows provide natural light to this space.

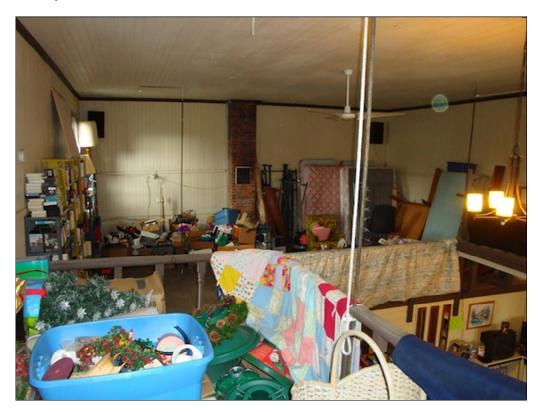
Photo 15 of 16. Upper floor space from mezzanine, looking west.

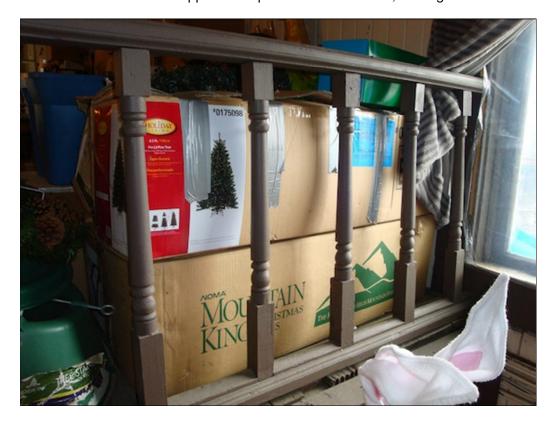
Photo 16 of 16. Detail of mezzanine rail balustrade.

The southwest corner of the mezzanine appears to have been truncated, probably to accommodate the current stair, which is a later, undated alteration. The rail in this area shows signs of having been altered, particularly in that it dies somewhat awkwardly into the trim of the upper window. It is possible that the mezzanine's original configuration was entirely symmetrical, and that access to the upper level was achieved from a point further to the rear of the building, but this has not been confirmed. Deciphering changes through analysis of flooring patches and rail details is difficult for reasons of limited accessibility (the mezzanine is currently used for storage of large boxes and business merchandise/stock).
